# Access Compliance Report

## Public Rights-of-Way

| Intersection ID: 19935 | Main Street: MORRISON_BV | Cross Street: ADAIR_CT | Location: SE |
| ADA ID: 9CA82EDE5A94 | Ramp Type: BlendTrans2 | Initial Pass/Fail: Fail | Overall Compliance: No |

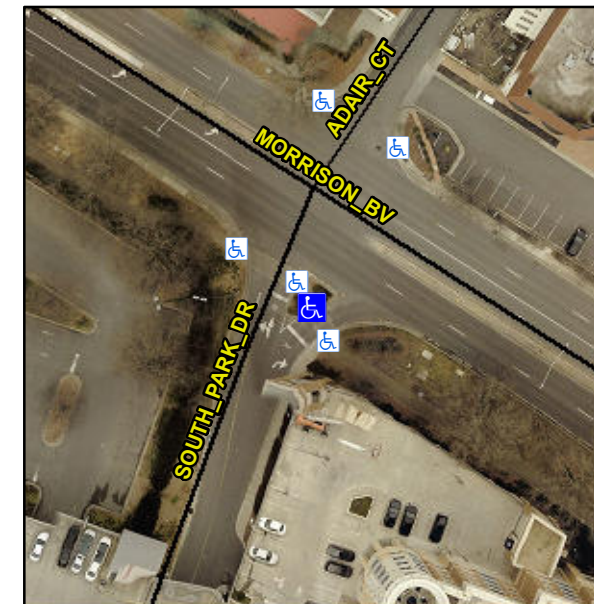
**XWALK PAVERS**

**Not Found, R304.5.3**

**Remove & Replace Curb Ramp With Two New Directional Ramps or Equivalent.**

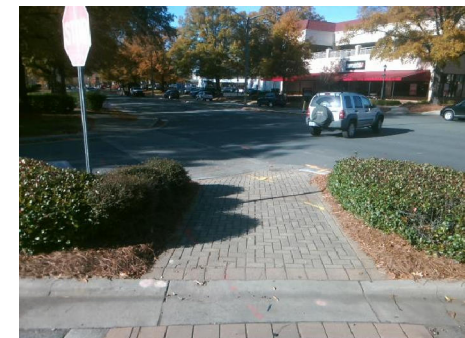
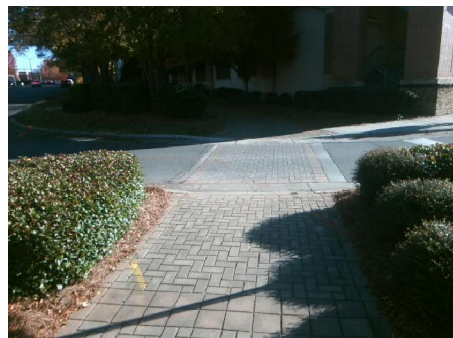
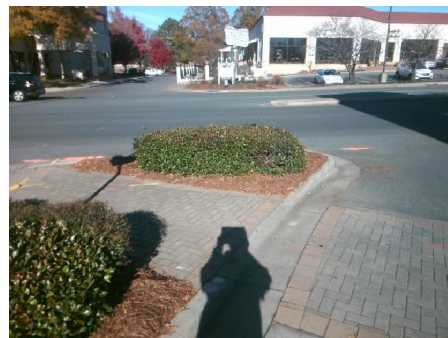
| Compliance | Description | Data | Compliance | Description | Data |
|---|---|---|---|---|---|
| Yes | Ramp Width (in) | 48.0 | No | BlendTrans XSlope (%) | 2.5 |
| | | | No | Curb Slope (%) | 6.8 |
