Access Compliance Report

Public Rights-of-Way

(Curb Ramps)

Intersection ID: 6598	Main Street: CATHEY_RD	Cross Street: PECANWOOD_RD	Location: SE
ADA ID: 9D28660F032D	Ramp Type: Perp	Initial Pass/Fail: Fail	Overall Compliance: No
			Severity Score: 33.75

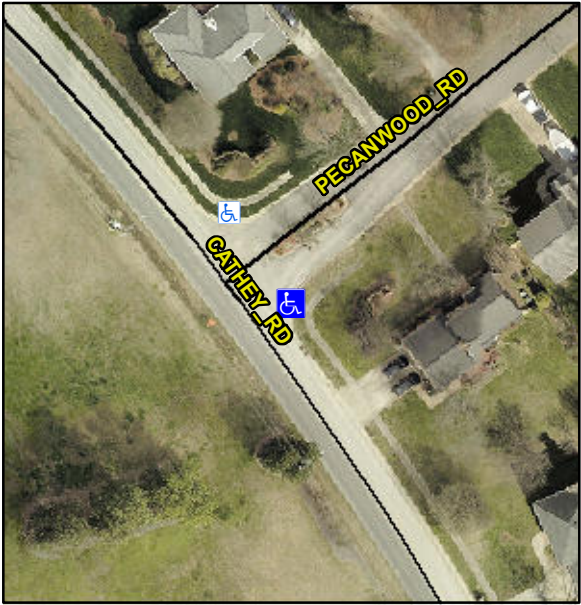
Possible Solutions:		Compliance	Description	Data
	Remove & Replace Entire Ramp.		N/A	Ramp Length (in)	84.0
			No	Ramp Width (in)	44.0
			N/A	Flare Type LT	N/A
			N/A	Flare Slope LT (%)	N/A
			N/A	Flare Traversable LT?	N/A
			N/A	Landing Length (in)	N/A
			N/A	Landing Width (in)	N/A
			N/A	Landing Slope (%)	N/A
			N/A	Landing X Slope (%)	N/A
<p>Surveyor Notes:</p> <p>N/A</p> <p>PROW/ADA:</p> <p>Not Found, R304.5.1, R304.2.2</p>			N/A	Flare Type RT	N/A
			N/A	Flare Slope RT (%)	N/A
			N/A	Flare Traversable RT?	N/A
			N/A	DWS Provided?	N/A
			N/A	DWS Contrast?	N/A
			N/A	DWS Length (in)	N/A
			N/A	DWS Full Width?	N/A
			N/A	DWS Offset (in)	N/A
			N/A	Gutter Ponding?	Yes
			N/A	Gutter Lip Ht (in)	N/A
<p>Total Cost:</p> <p>\$ 1850.00</p>			N/A	Painted X Walk1?	No
				X Walk 1 Direction	To NW
			N/A	X Walk 1 Width (in)	N/A
				X Walk 1 Slope (%)	3.6

X Walk 1 X Slope (%)	2.4
			N/A	Ramp inside XWalk1?	N/A
				Road Slope (%)	N/A
				Road X Slope (%)	N/A
			N/A	Any Obstructions?	N/A
				Obstruction Type	
			N/A	Storm Grate/Utility Hazard?	N/A
			N/A	Storm Grate/Utility Type	
			N/A	Surface Condition? (G/P)	Good
