Intersection ID: 10041692	Main Street: WILBURN_CT	Cross Street: N/A	Location:	E
ADA ID: 9DE929DB07E4	Ramp Type: Perp	Initial Pass/Fail: Fail	Overall Compliance: No	Severity Score: 21.25

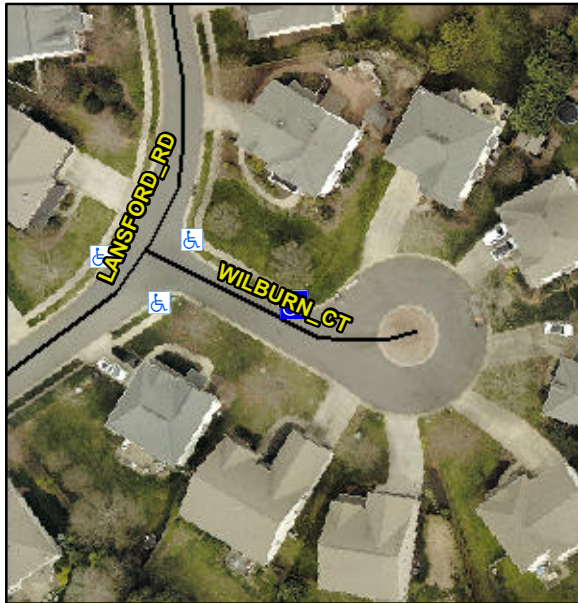
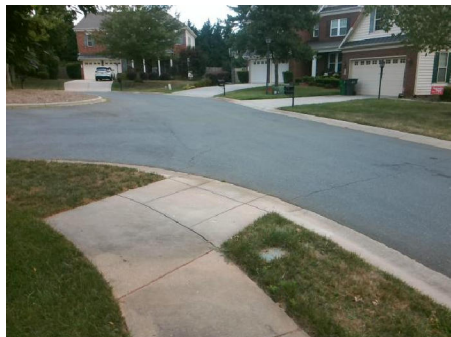
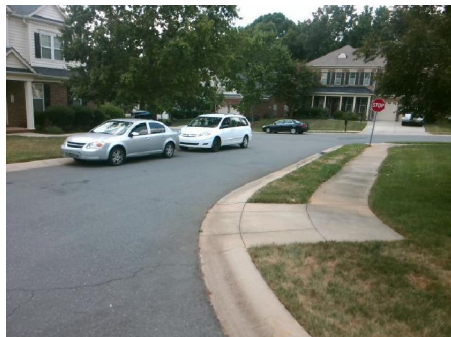
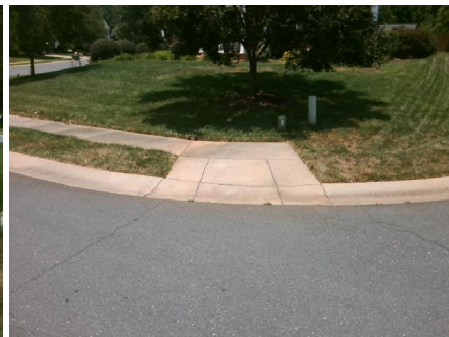
Not Found, R304.5.1, R304.5.3

Possible Solutions:			Compliance	Description	Data	Compliance	Description	Data
Remove & Replace Entire Ramp.	N/A	Ramp Length (in)	48.0	Yes	Ramp Slope (%)	6.3		
	No	Ramp Width (in)	42.0	No	Ramp XSlope (%)	5.2		
	N/A	Flare Type LT	N/A	N/A	Flare Type RT	N/A		
	N/A	Flare Slope LT (%)	N/A	N/A	Flare Slope RT (%)	N/A		
	N/A	Flare Traversable LT?	N/A	N/A	Flare Traversable RT?	N/A		
	N/A	Landing Length (in)	N/A	N/A	DWS Provided?	N/A		
	N/A	Landing Width (in)	N/A	N/A	DWS Contrast?	N/A		
	N/A	Landing Slope (%)	N/A	N/A	DWS Length (in)	N/A		
	N/A	Landing X Slope (%)	N/A	N/A	DWS Full Width?	N/A		
	N/A	Landing Curb? (Y/N)	N/A	N/A	DWS Offset (in)	N/A		
Surveyor Notes:	N/A	Shared Landing?	N/A					
PROW/ADA:	N/A	Gutter Ponding?	N/A	N/A	Gutter Slope (%)	N/A		
	N/A	Gutter Lip Ht (in)	N/A	N/A	Gutter X Slope (%)	N/A		
	N/A	Painted X Walk1?	No	N/A	Painted X Walk2?	N/A		
		X Walk 1 Direction	To S		X Walk 2 Direction	N/A		
	N/A	X Walk 1 Width (in)	N/A	N/A	X Walk 2 Width (in)	N/A

Remove & Replace Entire Ramp.
