Access Compliance Report Public Rights-of-Way (Curb Ramps)

•		-					
Intersection ID: 3612	Main Street: BRIDLE_RIDGE_LN				Street:	FURLONG_TL	Location:	NE		
ADA ID: 9E0FA7AA846B	Ramp Type: Perp			Initial Pass/Fail: Fail Overall Compliance: No					o Severity Score:	21.25
Codes/Mitigation Info/Possible Solution				Field Measurements/Component Compliance						
Possible Solutions:			Compliance Description Data Co			Comp	Compliance Description Data			
DERIGE . CONTRACTOR OF	3	Remove & Replace E	ntire Ramp.		N/A	Ramp Length (in)	48.0	Yes	Ramp Slope (%)	6.9
	COLO COMPANY				No	Ramp Width (in)	47.5	No	Ramp XSlope (%)	5.1
1 DE LA					N/A	Flare Type LT	N/A	N/A	Flare Type RT	N/A
					N/A	Flare Slope LT (%)	N/A	N/A	Flare Slope RT (%)	N/A
					N/A	Flare Traversable LT?	N/A	N/A	Flare Traversable RT?	N/A
					N/A	Landing Length (in)	N/A	N/A	DWS Provided?	N/A
	C Ste	Surveyor Notes:			N/A	Landing Width (in)	N/A	N/A	DWS Contrast?	N/A
A BLOW		N/A			N/A	Landing Slope (%)	N/A	N/A	DWS Length (in)	N/A

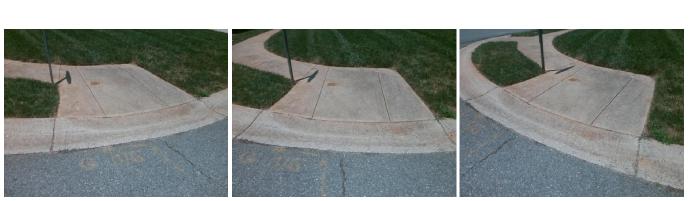
N. A. M.		, 1004.0.0		N/A	Painted X Walk1?	No	N/A	Painted X Walk2?	N/A
		2				X Walk 1 Direction	To S		X Walk 2 Direction	N/A
					N/A	X Walk 1 Width (in)	N/A	N/A	X Walk 2 Width (in)	N/A
Street 1 Name	FURLONG TL	•				X Walk 1 Slope (%)	1.0		X Walk 2 Slope (%)	N/A
Stop Condition-Street 2	StopSign					X Walk 1 X Slope (%)	2.7		X Walk 2 X Slope (%)	N/A
Street 2 Name	N/A				N/A	Ramp inside XWalk1?	N/A	N/A	Ramp inside XWalk2?	N/A
Stop Condition-Street 1	N/A					, Road Slope (%)	N/A	N/A	Clear Space?	N/A
						Road X Slope (%)	N/A	N/A	Clear Space to XWalk (in)	N/A
					N/A	Any Obstructions?	N/A	N/A	Storm Grate/Utility Hazard?	N/A
		Total Cost:	\$ 1	850.00		Obstruction Type			Storm Grate/Utility Type

Good
