# Access Compliance Report

## Public Rights-of-Way

| Intersection ID: 15457 | Main Street: EAST_BV | Cross Street: LOMBARDY_CR | Location: S |
| ADA ID: 9E1279E68408 | Ramp Type: BlendTrans1 | Initial Pass/Fail: Fail | Overall Compliance: No |

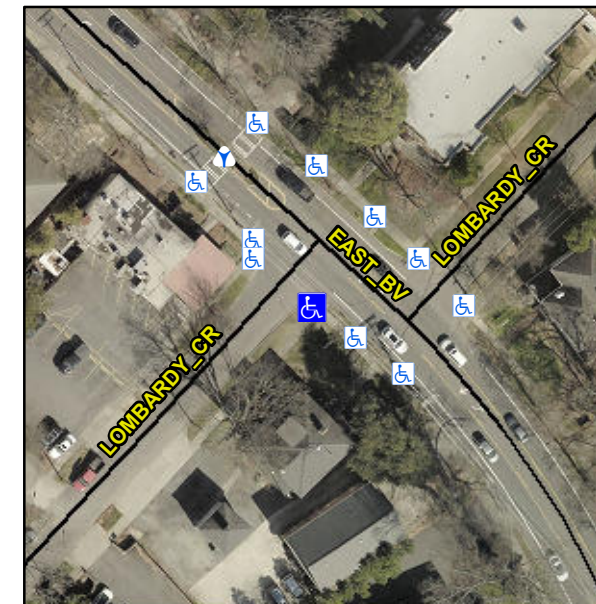
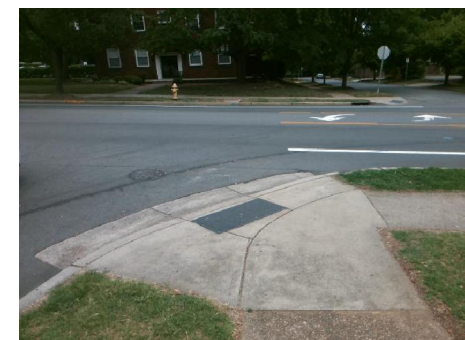
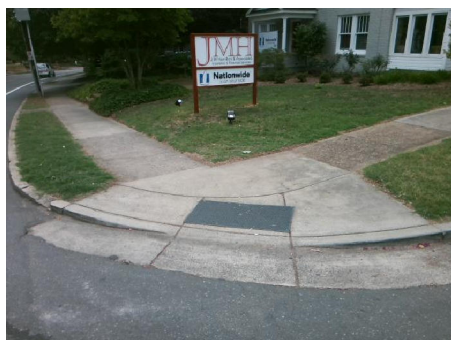
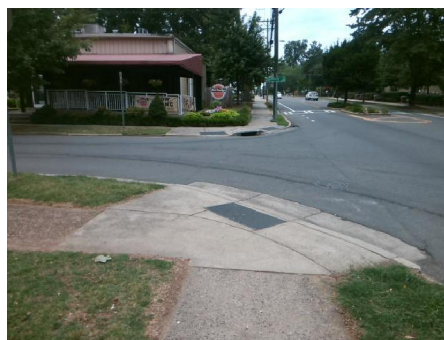
| Severity Score: 10 | | | |

**R304.5.1, R304.5.3**

| Compliance | Description | Data | Compliance | Description | Data |
|---|---|---|---|---|---|
| No | Ramp Width (in) | 42.0 | No | BlendTrans XSlope (%) | 3.6 |

**Remove & Replace Curb Ramp With Two New Directional Ramps or Equivalent.**
