# Access Compliance Report

## Public Rights-of-Way

### (Curb Ramps)

Intersection ID: 31699	Main Street: TIMBERTOP_LN	Cross Street: TIMBERTOP_LN	Location:	E
ADA ID: 9E80CC01D556	Ramp Type: Perp	Initial Pass/Fail: Fail	Overall Compliance: No	Severity Score: 10

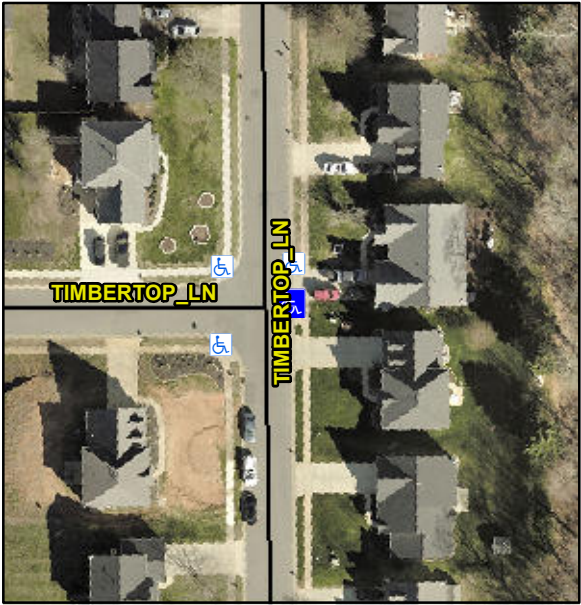
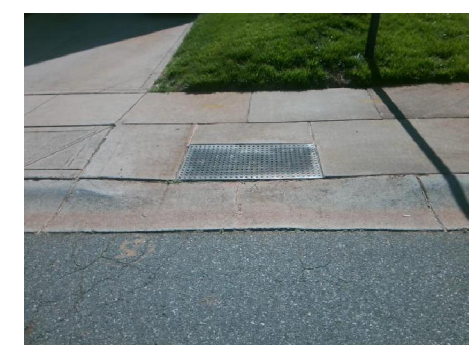
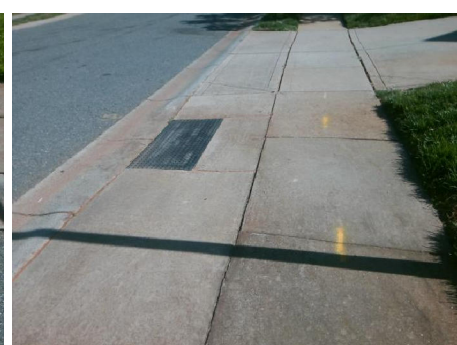
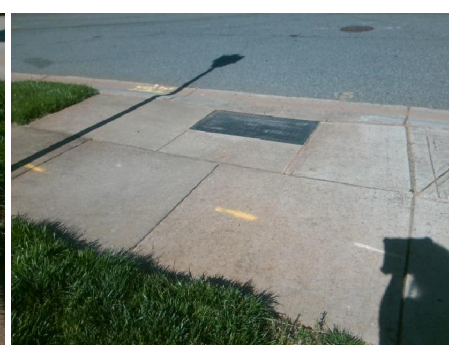
Possible Solutions:		<b>Compliance</b>	<b>Description</b>	<b>Data</b>	
	<b>Remove &amp; Replace Entire Ramp.</b>		<b>N/A</b>	Ramp Length (in)	<b>47.0</b>	<b>Yes</b>
			<b>No</b>	Ramp Width (in)	<b>47.5</b>	<b>Yes</b>
			<b>N/A</b>	Flare Type LT	<b>N/A</b>	<b>N/A</b>
			<b>N/A</b>	Flare Slope LT (%)	<b>N/A</b>	<b>N/A</b>
			<b>N/A</b>	Flare Traversable LT?	<b>N/A</b>	<b>N/A</b>
			<b>N/A</b>	Landing Length (in)	<b>N/A</b>	<b>N/A</b>
			<b>N/A</b>	Landing Width (in)	<b>N/A</b>	<b>N/A</b>
			<b>N/A</b>	Landing Slope (%)	<b>N/A</b>	<b>N/A</b>
			<b>N/A</b>	Landing X Slope (%)	<b>N/A</b>	<b>N/A</b>
			<b>N/A</b>	Landing Curb? (Y/N)	<b>N/A</b>	<b>N/A</b>
			<b>N/A</b>	Shared Landing?	<b>N/A</b>	
			<b>N/A</b>	Gutter Ponding?	<b>N/A</b>	<b>N/A</b>
			<b>N/A</b>	Gutter Lip Ht (in)	<b>0.5</b>	<b>N/A</b>
			<b>N/A</b>	Painted X Walk1?	<b>No</b>	<b>N/A</b>

X Walk 1 Direction	<b>To W</b>	
			<b>N/A</b>	X Walk 1 Width (in)	<b>N/A</b>	<b>N/A</b>
				X Walk 1 Slope (%)	<b>0.1</b>	
				X Walk 1 X Slope (%)	<b>4.7</b>	
			<b>N/A</b>	Ramp inside XWalk1?	<b>N/A</b>	<b>N/A</b>
<p>Surveyor Notes:</p> <p><b>N/A</b></p> <p>PROW/ADA:</p> <p><b>Not Found, R304.5.1</b></p>			<b>N/A</b>	Road Slope (%)	<b>4.7</b>	<b>N/A</b>
				Road X Slope (%)	<b>0.1</b>	<b>N/A</b>
			<b>N/A</b>	Any Obstructions?	<b>N/A</b>	<b>N/A</b>
				Obstruction Type		
					<b>N/A</b>	<b>N/A</b>
			<b>Yes</b>	Surface Condition? (G/P)		<b>Good</b>
Total Cost:		\$ 1850.00
