# Access Compliance Report

## Public Rights-of-Way

### (Curb Ramps)

| Intersection ID: N/A | | Main Street: DIXIE_RIVER_RD | | Cross Street: GLENBURN_LN | | Location: NW | | | | | |

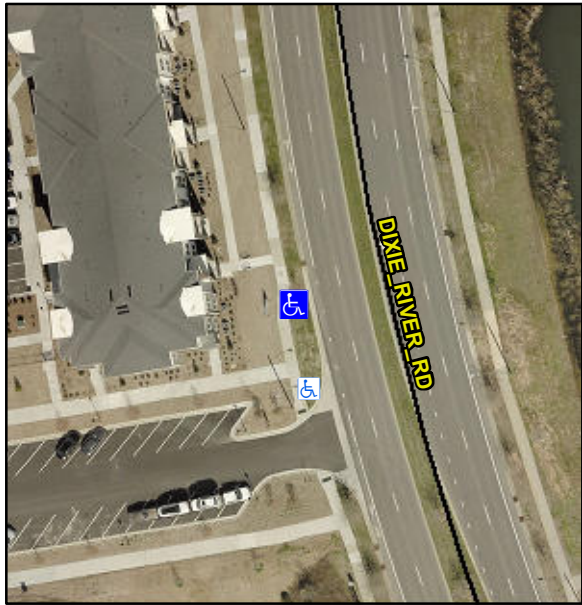
| ADA ID: 9EC9B024E00B | | Ramp Type: Directional1 | | Initial Pass/Fail: Pass | | Overall Compliance: No | | Severity Score: 17.5 | | | |
| | | | | Remove & Replace Gutter. | | Yes | Ramp Width (in) | 67.0 | No | Grade Break Slope (%) | 6.3 |
| Surveyor Notes:<br><br>N/A | | | | No | Landing Slope (%) | 3.5 | Yes | DWS Length (in) | 24.0 | | |
| | | | | Yes | Landing X Slope (%) | 0.9 | No | DWS Full Width? | No | | |
| | | | | No | Gutter Lip Ht (in) | 2.0 | No | Gutter X Slope (%) | 3.1 | | |
| PROW/ADA:<br><br>Not Found, R304.2.2-Perp, R304.3.2-Para, R304.5.3, R305.1.4, R302.7.2 | | | | Yes | X Walk 1 X Slope (%) | 0.4 | Yes | Storm Grate/Utility Hazard? | No | | |

| | | | | Remove & Replace Entire Ramp. | | N/A | Ramp Length (in) | 70.0 | Yes | Grade Break? | Yes |
