# Access Compliance Report

## Public Rights-of-Way

### (Curb Ramps)

| Intersection ID: 3853 | Main Street: CADENCIA_CT | Cross Street: GLASTON_LN | Location: S |

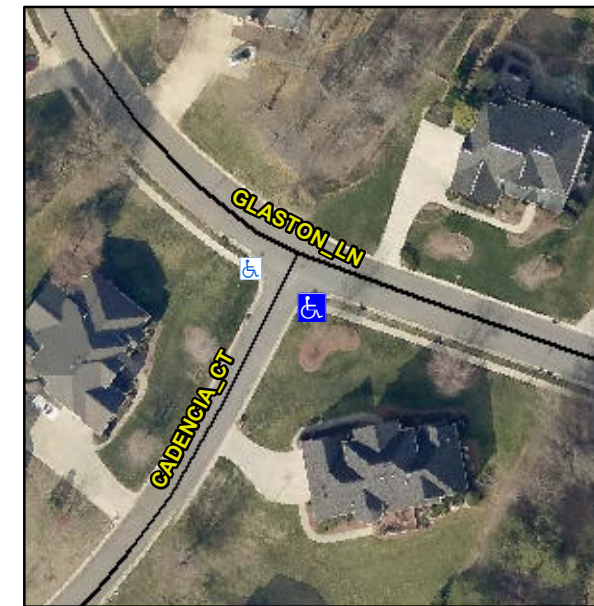
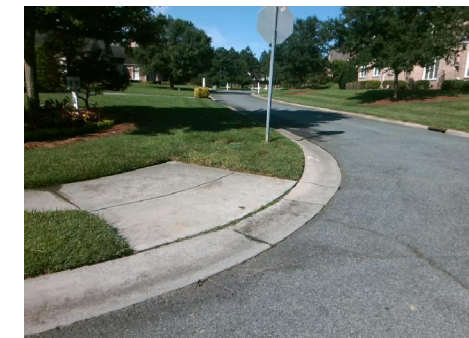
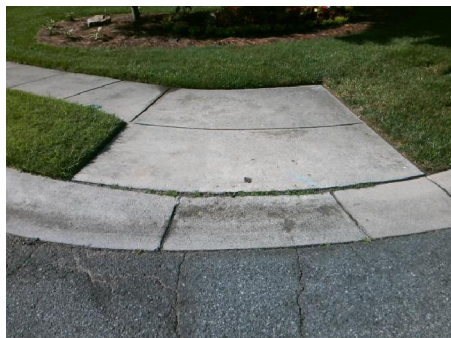
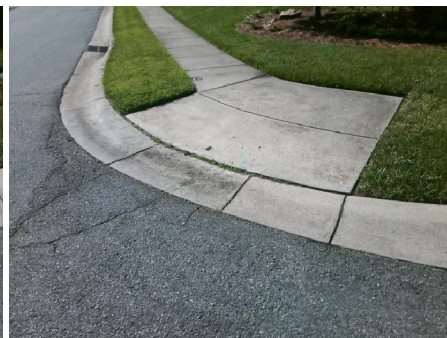
| ADA ID: 9F545278C56E | Ramp Type: Perp | Initial Pass/Fail: Pass | Overall Compliance: No |
| | | Severity Score: 30 | |

**R304.5.3, R305, R302.7.2, R304.5.4**

| Compliance | Description | Data | Compliance | Description | Data |
|---|---|---|---|---|---|
| Yes | Landing Length (in) | 53.0 | No | DWS Provided? | No |
| No | Landing X Slope (%) | 2.3 | N/A | DWS Full Width? | No |
| Yes | Gutter Ponding? | No | No | Gutter Slope (%) | 6.7 |
| No | Gutter Lip Ht (in) | 1.0 | No | Gutter X Slope (%) | 3.7 |

**Remove & Replace Entire Ramp.  
Remove & Replace Gutter.**
