Access Compliance Report

Public Rights-of-Way

| Intersection ID: 23717 | Main Street: E WESTINGHOUSE BV | Cross Street: CHINA GROVE CHURCH RD | Location: NW |
| ADA ID: 9FD752E46C72 | Ramp Type: PerpDiag | Initial Pass/Fail: Fail | Overall Compliance: No Severity Score: 21.25 |

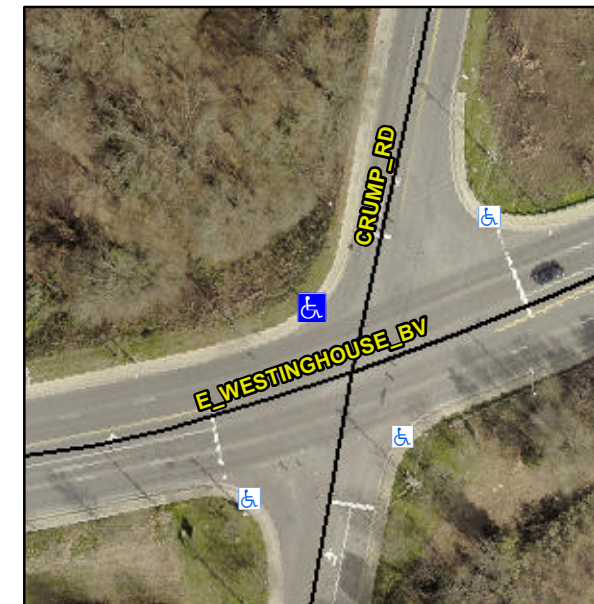
Not Found, R304.5.1, R304.2.2

| Compliance | Description | Data | Compliance | Description | Data |
|---|---|---|---|---|---|
| N/A | Ramp Length (in) | 53.0 | No | Ramp Slope (%) | 11.2 |
| No | Ramp Width (in) | 44.0 | Yes | Ramp XSlope (%) | 1.6 |

Remove & Replace Curb Ramp With Two New Directional Ramps or Equivalent.
