Access Compliance Report

Public Rights-of-Way

(Curb Ramps)

| Intersection ID: 5229 | Main Street: BIANCA_CT | Cross Street: NORTHWOODS_FOREST_DR | Location: NE |

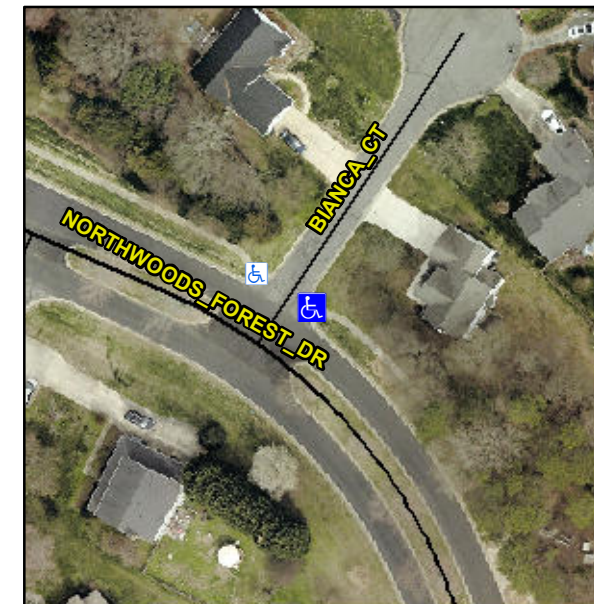
Not Found, R304.5.3

| Compliance | Description | Data | Compliance | Description | Data |
|---|---|---|---|---|---|
| Yes | Ramp Width (in) | 64.0 | No | Ramp XSlope (%) | 3.7 |

Remove & Replace Entire Ramp.
