# Access Compliance Report

## Public Rights-of-Way (Curb Ramps)

| Intersection ID: 53350 | Main Street: SAPPHIRE_HILL_LN | Cross Street: LOST_CANYON_WY | Location: W |
| ADA ID: A040A1A1B7C7 | Ramp Type: BlendTrans1 | Initial Pass/Fail: Fail | Overall Compliance: No |

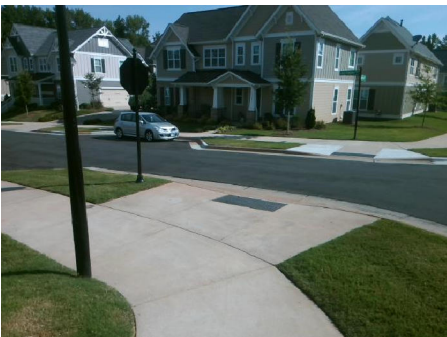
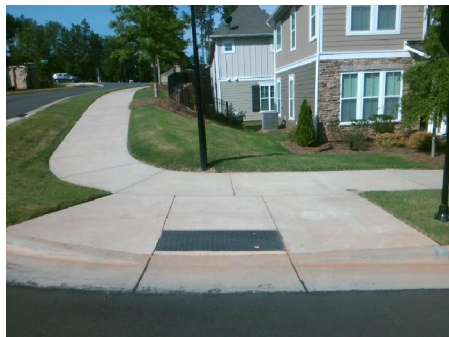
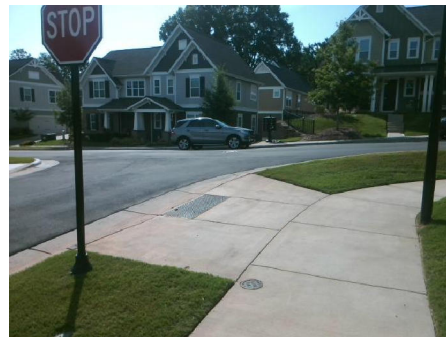
| | | Severity Score: 25 | |

**Not Found, R304.5.3**

| Compliance | Description | Data | Compliance | Description | Data |
|---|---|---|---|---|---|
| Yes | Ramp Width (in) | 60.0 | No | BlendTrans XSlope (%) | 7.9 |
| | | | No | Curb Slope (%) | 11.7 |

**Remove & Replace Curb Ramp With Two New Directional Ramps or Equivalent.**
