# Access Compliance Report

## Public Rights-of-Way

| Intersection ID: 50321 | Main Street: BELMAR_PLACE_RD | Cross Street: CINDY_LN | Location: NE |
| ADA ID: A06640F8590B | Ramp Type: Directional1 | Initial Pass/Fail: Pass | Overall Compliance: No |

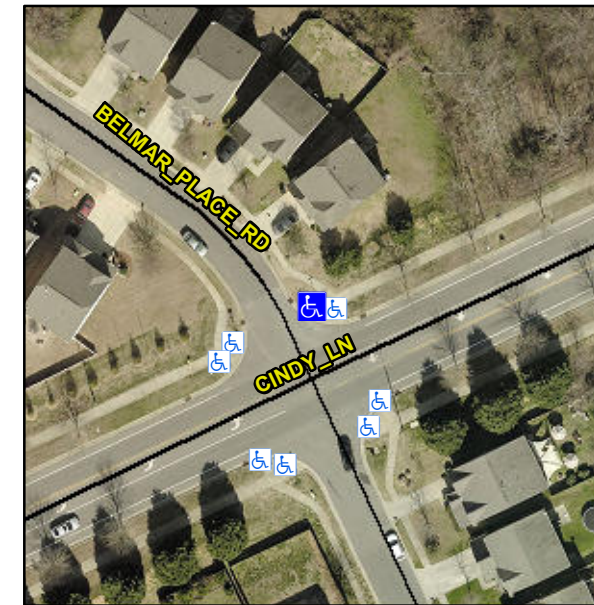
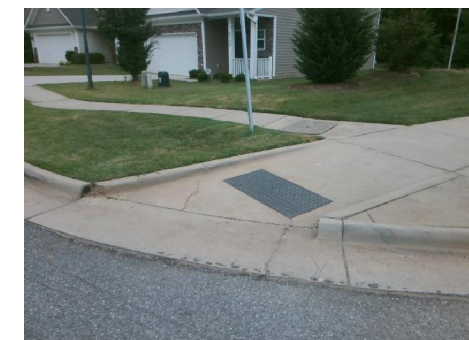
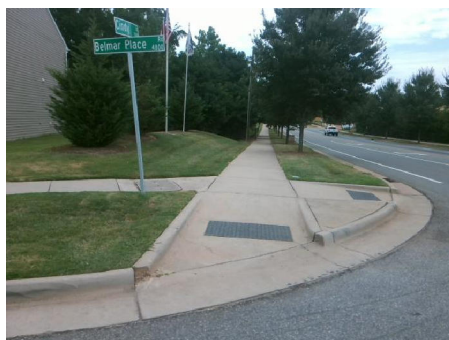
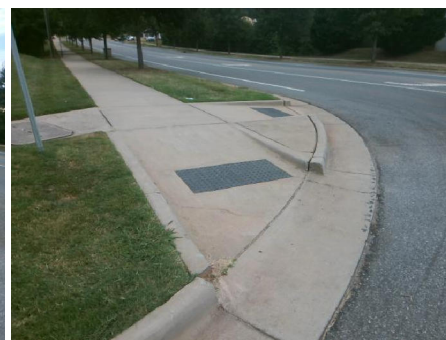
| Codes/Mitigation Info/Possible Solution | | | Severity Score: 10 |

**R304.5.3, R305.1.4, R305.2, R302.7.2**

| Compliance | Description | Data | Compliance | Description | Data |
|---|---|---|---|---|---|
| No | Landing X Slope (%) | 2.1 | No | DWS Full Width? | No |
| N/A | Shared Landing? | Yes | No | DWS Offset RT (in) | 8.5 |
| No | Gutter Lip Ht (in) | 0.3 | Yes | Gutter X Slope (%) | 1.6 |

**Remove & Replace Entire Ramp.  
Grind Gutter Lip.**

**\$ 1800.00**
