Access Compliance Report

Public Rights-of-Way

(Curb Ramps)

Intersection ID: 52127	Main Street: VALLEYDALE_RD	Cross Street: FRED_D_ALEXANDER_BV	Location: W
ADA ID: A06CD61C967C	Ramp Type: Combination1	Initial Pass/Fail: Pass	Overall Compliance: No
			Severity Score: 2.75

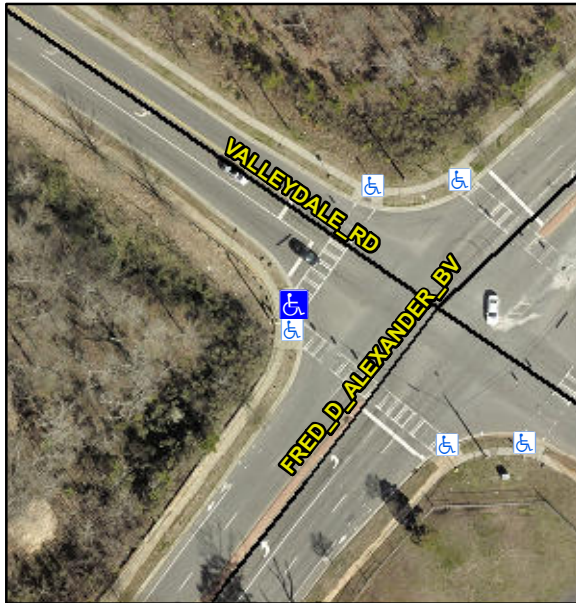
RP & RT RP < 5%

**Not Found, R304.5.3, R305.1.4,
R305.2**

Compliance	Description	Data	Compliance	Description	Data
N/A	Ramp Length LT (in)	61.0	N/A	Ramp Length RT (in)	55.0
Yes	Ramp Width LT (in)	60.0	Yes	Ramp Width RT (in)	60.0
Yes	Ramp Slope LT (%)	7.9	Yes	Ramp Slope RT (%)	4.6
Yes	Ramp XSlope LT (%)	0.5	No	Ramp XSlope RT (%)	2.1
N/A	Ramp Length (in)	63.0	Yes	Ramp Slope (%)	1.8
Yes	Ramp Width (in)	53.0	Yes	Ramp XSlope (%)	0.3
N/A	Flare Type LT	Sloped	N/A	Flare Type RT	Sloped
Yes	Flare Slope LT (%)	7.4	Yes	Flare Slope RT (%)	4.6
N/A	Flare Traversable LT?	Yes	N/A	Flare Traversable RT?	Yes
Yes	Landing Length (in)	59.0	Yes	DWS Provided?	Yes
Yes	Landing Width (in)	48.0	Yes	DWS Contrast?	Yes
Yes	Landing Slope (%)	0.5	Yes	DWS Length (in)	24.5
Yes	Landing X Slope (%)	1.2	No	DWS Full Width?	No
N/A	Landing Curb? (Y/N)	No	No	DWS Offset (in)	3.5
N/A	Shared Landing?	Yes			
Yes	Gutter Ponding?	No	Yes	Gutter Slope (%)	3.6
Yes	Gutter Lip Ht (in)	0.0	Yes	Gutter X Slope (%)	0.6
N/A	Painted X Walk1?	Yes	N/A	Painted X Walk2?	N/A

**Remove & Replace Entire Ramp.
Remove & Replace Sidewalk.**
