Access Compliance Report

Public Rights-of-Way

(Curb Ramps)

Intersection ID: 49398	Main Street: HEREFORD_ST	Cross Street: BARROSO_LN	Location: SW
ADA ID: A075FF2E8FA4	Ramp Type: BlendTrans1	Initial Pass/Fail: Fail	Overall Compliance: No
Severity Score: 10			
Codes/Mitigation Info/Possible Solution		Field Measurements/Component Compliance

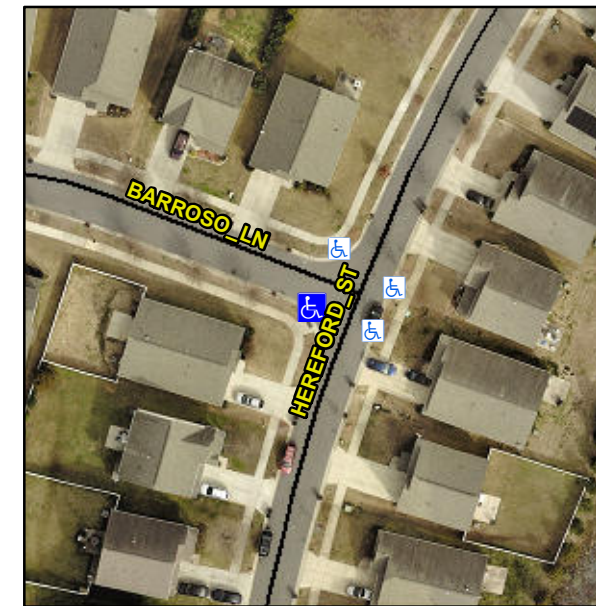
Not Found, R304.5.1, R304.5.3

Compliance	Description	Data	Compliance	Description	Data
N/A	Ramp Length (in)	72.0	Yes	BlendTrans Slope (%)	4.4
No	Ramp Width (in)	47.0	No	BlendTrans XSlope (%)	2.1
N/A	Flare Type LT	N/A	N/A	Flare Type RT	N/A
N/A	Flare Slope LT (%)	N/A	N/A	Flare Slope RT (%)	N/A
N/A	Flare Traversable LT?	N/A	N/A	Flare Traversable RT?	N/A
N/A	Landing Length (in)	N/A	N/A	DWS Provided?	N/A
N/A	Landing Width (in)	N/A	N/A	DWS Contrast?	N/A
N/A	Landing Slope (%)	N/A	N/A	DWS Length (in)	N/A
N/A	Landing X Slope (%)	N/A	N/A	DWS Full Width?	N/A
N/A	Landing Curb? (Y/N)	N/A	N/A	DWS Offset (in)	N/A
N/A	Shared Landing?	N/A			
N/A	Gutter Ponding?	N/A	N/A	Gutter Slope (%)	N/A
N/A	Gutter Lip Ht (in)	N/A	N/A	Gutter X Slope (%)	N/A
N/A	Painted X Walk1?	No	N/A	Painted X Walk2?	No
	X Walk 1 Direction	To SE		X Walk 2 Direction	To NE
	X Walk 1 Width (in)	N/A		X Walk 2 Width (in)	N/A
	X Walk 1 Slope (%)	2.9		X Walk 2 Slope (%)	1.1
	X Walk 1 X Slope (%)	2.2		X Walk 2 X Slope (%)	2.3

N/A	Ramp inside XWalk1?	N/A	N/A	Ramp inside XWalk2?	N/A
	Road Slope (%)	2.9		Clear Space?	N/A
	Road X Slope (%)	0.2	N/A	Clear Space to XWalk (in)	N/A
N/A	Any Obstructions?	N/A	N/A	Storm Grate/Utility Hazard?	N/A
	Obstruction Type			Storm Grate/Utility Type	
		N/A			N/A
			Yes	Surface Condition? (G/P)	Good
			No	Curb Slope (%)	15.0

Remove & Replace Curb Ramp With Two New Directional Ramps or Equivalent.
