Access Compliance Report

Public Rights-of-Way

(Curb Ramps)

| Intersection ID: 2684 | Main Street: CARDINAL_POINT_RD | Cross Street: SUMMERGOLD_WY | Location: SW |

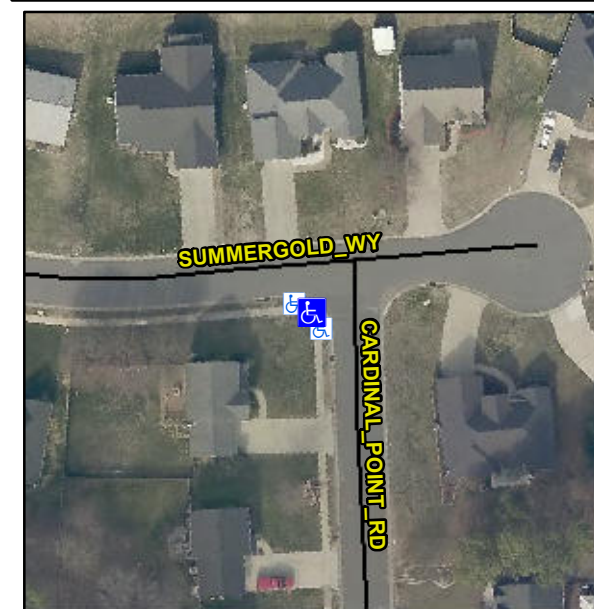
| Severity Score: 12.5 | | | |

Not Found, R304.2.2

| Compliance | Description | Data | Compliance | Description | Data |
|---|---|---|---|---|---|
| N/A | Ramp Length (in) | 49.0 | No | Ramp Slope (%) | 9.1 |

Remove & Replace Entire Ramp.
