Access Compliance Report Public Rights-of-Way (Curb Ramps)

Intersection ID: 10030167 Main Street: LATROBE_DR Cross Street: N/A Location: NE

ADA ID: A0D8E359C930 Ramp Type: Directional1 Initial Pass/Fail: Fail Overall Compliance: No Severity Score: 18.75

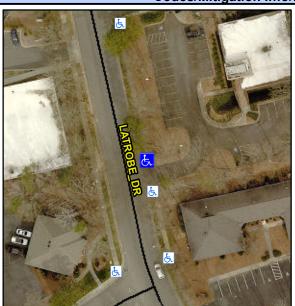
Possible Solutions:	Comp	liance Description		
Remove & Replace Entire Ramp.	N/A	Ramp Length (in)		
•	No	Ramp Width (in)		
	Yes	Ramp Slope (%)		
	Yes	Ramp XSlope (%)		
	N/A	Flare Type LT		
	N/A	Flare Slope LT (%)		
Surveyor Notes:	N/A	Flare Traversable LT?		
N/A	N/A	Landing Length (in)		
	N/A	Landing Width (in)		
	N/A	Landing Slope (%)		
	N/A	Landing X Slope (%)		
PROW/ADA:	N/A	Landing Curb? (Y/N)		
R304.5.1	N/A	Shared Landing?		
	N/A	Gutter Ponding?		
	N/A	Gutter Lip Ht (in)		
	N/A	Painted X Walk1?		
		X Walk 1 Direction		
		X Walk 1 Width (in)		
		X Walk 1 Slope (%)		
		X Walk 1 X Slope (%)
