Access Compliance Report

Public Rights-of-Way

(Curb Ramps)

Intersection ID: 53537	Main Street: MACFARLANE_BV	Cross Street: IKEA_BV	Location:	N
ADA ID: A11A1B649FA4	Ramp Type: Perp	Initial Pass/Fail: Fail	Overall Compliance: No	Severity Score: 10

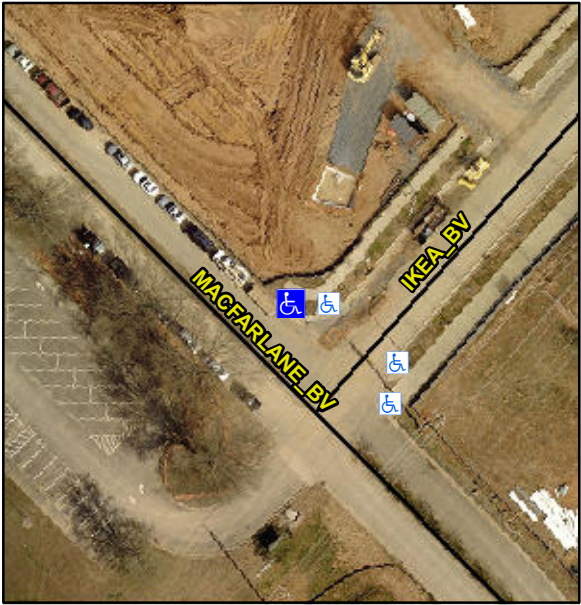
Possible Solutions:		Compliance	Description	Data
	Remove & Replace Entire Ramp.		N/A	Ramp Length (in)	96.0
			No	Ramp Width (in)	45.0
			N/A	Flare Type LT	N/A
			N/A	Flare Slope LT (%)	N/A
			N/A	Flare Traversable LT?	N/A
			N/A	Landing Length (in)	N/A
			N/A	Landing Width (in)	N/A
			N/A	Landing Slope (%)	N/A
			N/A	Landing X Slope (%)	N/A
<p>Surveyor Notes:</p> <p>N/A</p> <p>PROW/ADA:</p> <p>Not Found, R304.5.1, R304.5.3</p>			N/A	Flare Type RT	N/A
			N/A	Flare Slope RT (%)	N/A
			N/A	Flare Traversable RT?	N/A
			N/A	DWS Provided?	N/A
			N/A	DWS Contrast?	N/A
			N/A	DWS Length (in)	N/A
			N/A	DWS Full Width?	N/A
			N/A	DWS Offset (in)	N/A
			N/A	Shared Landing?	N/A
			N/A	Gutter Ponding?	N/A
			N/A	Gutter Lip Ht (in)	1.0
			N/A	Painted X Walk1?	No
				X Walk 1 Direction	To SW
			N/A	X Walk 1 Width (in)	N/A
				X Walk 1 Slope (%)	5.0

X Walk 1 X Slope (%)	1.0
			N/A	Ramp inside XWalk1?	N/A
				Road Slope (%)	N/A
				Road X Slope (%)	N/A
			N/A	Any Obstructions?	N/A
				Obstruction Type	
Total Cost:		\$ 1850.00			
			N/A		N/A
			Yes	Surface Condition? (G/P)	Good
