Access Compliance Report Public Rights-of-Way (Curb Ramps)

Intersection ID: 5588 Main Street: CARVER_BV Cross Street: ROCKWELL_BV Location: S

ADA ID: A13EACF4D314 Ramp Type: Para Initial Pass/Fail: Fail Overall Compliance: No Severity Score: 21.25

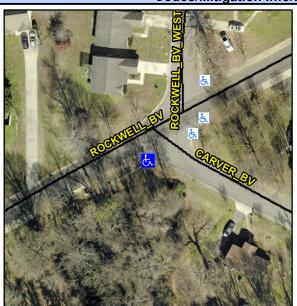
R304.5.1, R304.3.2

Field Measurements/Component Compliance					
Compliance Description		Data	Compliance Description		Data
N/A	Ramp Length LT (in)	67.0	N/A	Ramp Length RT (in)	60.5
No	Ramp Width LT (in)	36.0	No	Ramp Width RT (in)	36.0
No	Ramp Slope LT (%)	9.6	Yes	Ramp Slope RT (%)	5.5
Yes	Ramp XSlope LT (%)	0.6	Yes	Ramp XSlope RT (%)	0.4
N/A	Landing Length (in)	N/A	N/A	DWS Provided?	N/A
N/A	Landing Width (in)	N/A	N/A	DWS Contrast?	N/A
N/A	Landing Slope (%)	N/A	N/A	DWS Length (in)	N/A
N/A	Landing X Slope (%)	N/A	N/A	DWS Full Width?	N/A
N/A	Landing Curb? (Y/N)	N/A	N/A	DWS Offset (in)	N/A
N/A	Shared Landing?	N/A			
N/A	Gutter Ponding?	N/A	N/A	Gutter Slope (%)	N/A
N/A	Gutter Lip Ht (in)	1.0	N/A	Gutter X Slope (%)	N/A
N/A	Painted X Walk1?	No	N/A	Painted X Walk2?	N/A
	X Walk 1 Direction	To NE		X Walk 2 Direction	N/A
N/A	X Walk 1 Width (in)	N/A	N/A	X Walk 2 Width (in)	N/A
	X Walk 1 Slope (%)	3.6		X Walk 2 Slope (%)	N/A
	X Walk 1 X Slope (%)	1.1		X Walk 2 X Slope (%)	N/A

Remove & Replace Entire Ramp.
