# Access Compliance Report

## Public Rights-of-Way

| Intersection ID: 50599 | Main Street: HEARTLEAF_RD | Cross Street: STREAM_ORCHID_LN | Location: NW |
| ADA ID: A188AF3B90B2 | Ramp Type: Perp | Initial Pass/Fail: Fail | Overall Compliance: No |

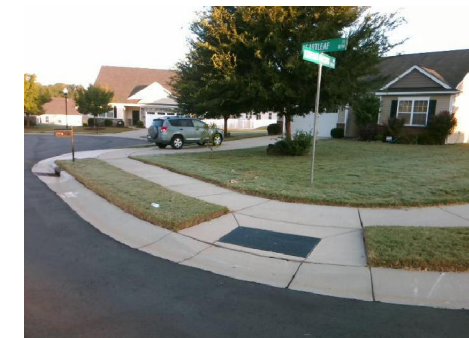
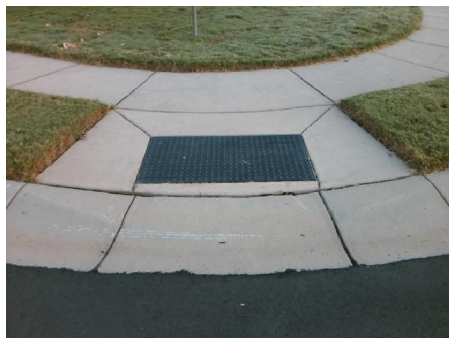
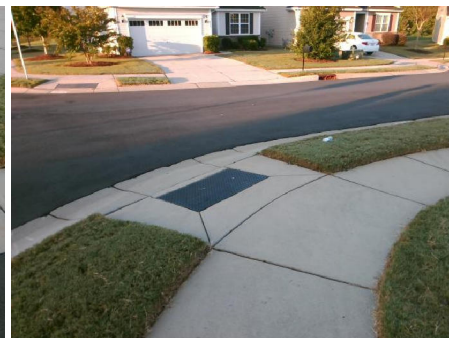
**Not Found, R304.5.3**

| Compliance | Description | Data | Compliance | Description | Data |
|---|---|---|---|---|---|
| Yes | Ramp Width (in) | 48.0 | No | Ramp XSlope (%) | 4.5 |

**Remove & Replace Entire Ramp.**
