Access Compliance Report Public Rights-of-Way (Curb Ramps)

Intersection ID: 15179Main Street:DRESDEN_DR_EASTCross Street:WESTCHESTER_BVLocation:NEADA ID: A1D5D513948FRamp Type:BlendTrans1Initial Pass/Fail:FailOverall Compliance:NoSeverity Score:10

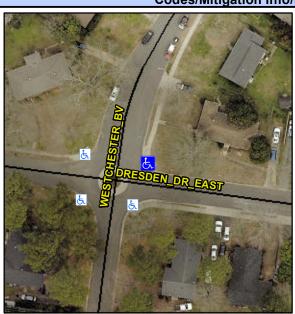
NO RT SW

Not Found, R304.5.1, R304.5.3

Remove & Replace Curb Ramp With Two New Directional Ramps or Equivalent.
