Access Compliance Report

Public Rights-of-Way

(Curb Ramps)

Intersection ID: 21262	Main Street: CARMEL_RD	Cross Street: PELLYN_WOOD_DR	Location: NE
ADA ID: A1EDB0032D92	Ramp Type: PerpDiag	Initial Pass/Fail: Fail	Overall Compliance: No
		Severity Score: 37.5

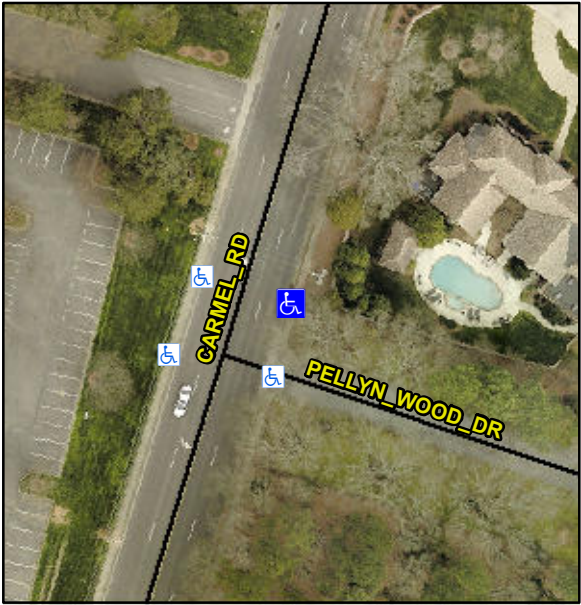
Possible Solutions:		Compliance	Description	Data
	Remove & Replace Curb Ramp With Two New Directional Ramps or Equivalent.		No	Ramp Length (in)	48.0
			Yes	Ramp Width (in)	48.0
			N/A	Flare Type LT	N/A
			N/A	Flare Slope LT (%)	N/A
			N/A	Flare Traversable LT?	N/A
			N/A	Landing Length (in)	N/A
			N/A	Landing Width (in)	N/A
			N/A	Landing Slope (%)	N/A
			N/A	Landing X Slope (%)	N/A
<p>Surveyor Notes:</p> <p>N/A</p> <p>PROW/ADA:</p> <p>Not Found, R304.2.2, R304.5.3</p>			N/A	Flare Type RT	N/A
			N/A	Flare Slope RT (%)	N/A
			N/A	Flare Traversable RT?	N/A
			N/A	DWS Provided?	N/A
			N/A	DWS Contrast?	N/A
			N/A	DWS Length (in)	N/A
			N/A	DWS Full Width?	N/A
			N/A	DWS Offset (in)	N/A
			N/A	Gutter Ponding?	N/A
			N/A	Gutter Lip Ht (in)	N/A
			No	Painted X Walk1?	No
				X Walk 1 Direction	To NW
			N/A	X Walk 1 Width (in)	N/A

3.1	X Walk 1 Slope (%)	3.4
			0.2	X Walk 1 X Slope (%)	4.5
			N/A	Ramp inside XWalk1?	N/A
			5.0	Road Slope (%)	N/A
			0.2	Road X Slope (%)	N/A
			N/A	Any Obstructions?	N/A
				Obstruction Type	
Total Cost: \$ 3200.00			N/A	Storm Grate/Utility Hazard?	N/A
			N/A	Storm Grate/Utility Type	N/A
			Yes	Surface Condition? (G/P)	Good
