Access Compliance Report Public Rights-of-Way (Curb Ramps)

Intersection ID: 14525 Main Street: ALBEMARLE_RD C					ross Street: FAULCONBRIDGE_RD				NW
ADA ID: A271998924BD				Initial Pass/Fail: Fail Overall Compliance: No				Location: o Severity Score:	12.5
Codes/Mitigation Info/Possible Solution				Field Measurements/Component Compliance					
1 5 30 1300		Possible Solutions:					Data Compliance Description		
		Remove & Replace Curb Ramp Wit Two New Directional Ramps or Equivalent.	Vith	N/A	Ramp Length (in)	60.5	No	Ramp Slope (%)	8.4
	and the set			Yes	Ramp Width (in)	48.0	Yes	Ramp XSlope (%)	0.7
	Stat a Mark			N/A	Flare Type LT	N/A	N/A	Flare Type RT	N/A
A State A				N/A	Flare Slope LT (%)	N/A	N/A	Flare Slope RT (%)	N/A
				N/A	Flare Traversable LT?	N/A	N/A	Flare Traversable RT?	N/A
Chill In a child	A STATE			N/A	Landing Length (in)	N/A	N/A	DWS Provided?	N/A
	10	Surveyor Notes:		N/A	Landing Width (in)	N/A	N/A	DWS Contrast?	N/A
		N/A		N/A	Landing Slope (%)	N/A	N/A	DWS Length (in)	N/A

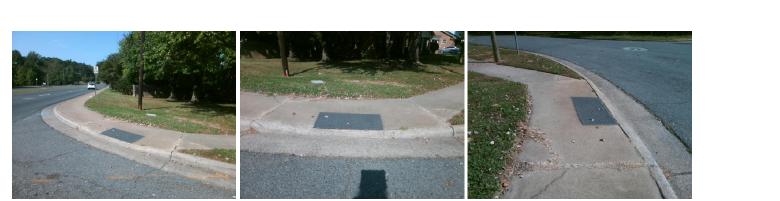
and the second	10			N/A	Landing X Slope (%)	N/A	N/A	DWS Full Width?	N/A
	R.E.			N/A	Landing Curb? (Y/N)	N/A	N/A	DWS Offset (in)	N/A
NEEE	Alter & Alter			N/A	Shared Landing?	N/A			
		PROW/ADA:		N/A	Gutter Ponding?	N/A	N/A	Gutter Slope (%)	N/A
	<u>G.</u>	Not Found, R304.2.2		N/A	Gutter Lip Ht (in)	1.0	N/A	Gutter X Slope (%)	N/A
		,		N/A	Painted X Walk1?	No	N/A	Painted X Walk2?	No
	S-F MERL				X Walk 1 Direction	To S		X Walk 2 Direction	To E
				N/A	X Walk 1 Width (in)	N/A	N/A	X Walk 2 Width (in)	N/A
Street 1 Name	ALBEMARLE RD	-			X Walk 1 Slope (%)	0.1		X Walk 2 Slope (%)	0.2
Stop Condition-Street 2	None				X Walk 1 X Slope (%)	0.2		X Walk 2 X Slope (%)	1.1
Street 2 Name	FAULCONBRIDGE RD			N/A	Ramp inside XWalk1?	N/A	N/A	Ramp inside XWalk2?	N/A
Stop Condition-Street 1	StopSign				Road Slope (%)	0.8	N/A	Clear Space?	N/A
					Road X Slope (%)	0.0	N/A	Clear Space to XWalk (in)	N/A
				N/A	Any Obstructions?	N/A	N/A	Storm Grate/Utility Hazard?	N/A

Total Cost: \$ 3	200.00		Obstruction Type			Storm Grate/Utility Type	
		····· ••••				N/A			N/A
						174			11/2
