Access Compliance Report

Public Rights-of-Way

(Curb Ramps)

Intersection ID: N/A	Main Street: PORTOLA_CT	Cross Street: N/A	Location: W
ADA ID: A33C88594DDE	Ramp Type: Perp	Initial Pass/Fail: Fail	Overall Compliance: No
Severity Score: 12.5			
Codes/Mitigation Info/Possible Solution		Field Measurements/Component Compliance

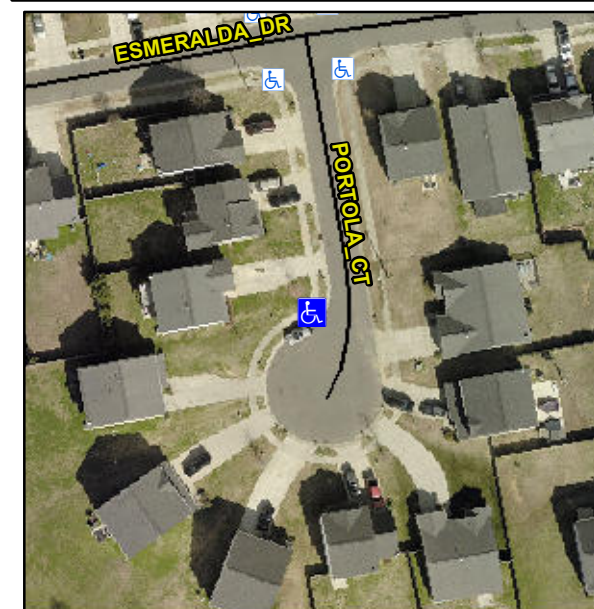
Not Found, R304.2.2

Compliance	Description	Data	Compliance	Description	Data
N/A	Ramp Length (in)	46.0	No	Ramp Slope (%)	9.8
Yes	Ramp Width (in)	48.0	Yes	Ramp XSlope (%)	0.7
N/A	Flare Type LT	N/A	N/A	Flare Type RT	N/A
N/A	Flare Slope LT (%)	N/A	N/A	Flare Slope RT (%)	N/A
N/A	Flare Traversable LT?	N/A	N/A	Flare Traversable RT?	N/A
N/A	Landing Length (in)	N/A	N/A	DWS Provided?	N/A
N/A	Landing Width (in)	N/A	N/A	DWS Contrast?	N/A
N/A	Landing Slope (%)	N/A	N/A	DWS Length (in)	N/A
N/A	Landing X Slope (%)	N/A	N/A	DWS Full Width?	N/A
N/A	Landing Curb? (Y/N)	N/A	N/A	DWS Offset (in)	N/A
N/A	Shared Landing?	N/A			
N/A	Gutter Ponding?	N/A	N/A	Gutter Slope (%)	N/A
N/A	Gutter Lip Ht (in)	N/A	N/A	Gutter X Slope (%)	N/A
N/A	Painted X Walk1?	No	N/A	Painted X Walk2?	N/A
	X Walk 1 Direction	To E		X Walk 2 Direction	N/A
N/A	X Walk 1 Width (in)	N/A	N/A	X Walk 2 Width (in)	N/A
	X Walk 1 Slope (%)	0.8		X Walk 2 Slope (%)	N/A
	X Walk 1 X Slope (%)	1.7		X Walk 2 X Slope (%)	N/A

Remove & Replace Entire Ramp.

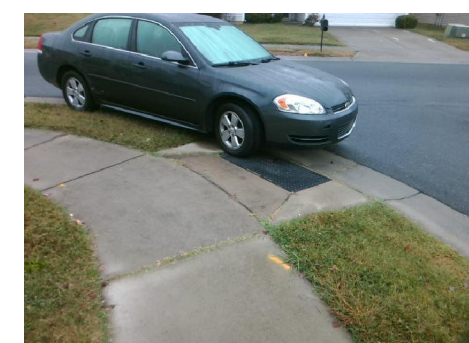
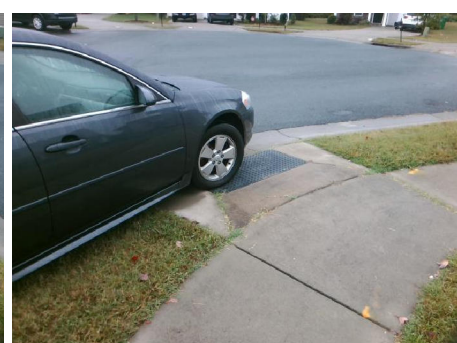
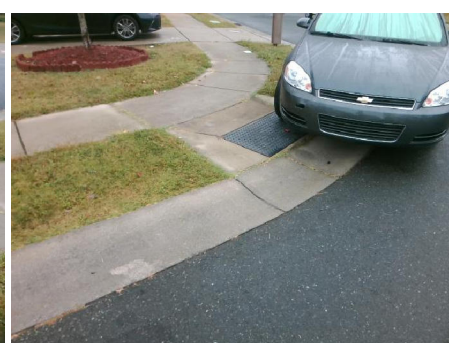
N/A	Ramp inside XWalk1?	N/A	N/A	Ramp inside XWalk2?	N/A
	Road Slope (%)	N/A	N/A	Clear Space?	N/A
	Road X Slope (%)	N/A	N/A	Clear Space to XWalk (in)	N/A
N/A	Any Obstructions?	N/A	N/A	Storm Grate/Utility Hazard?	N/A
	Obstruction Type			Storm Grate/Utility Type	
		N/A			N/A
		Yes		Surface Condition? (G/P)	Good
