# Access Compliance Report

## Public Rights-of-Way

| Intersection ID: 13369 | Main Street: WEST_BV | Cross Street: I-77 | Location: NW |
| ADA ID: A35461502FE8 | Ramp Type: ParaDiag | Initial Pass/Fail: Fail | Overall Compliance: No |

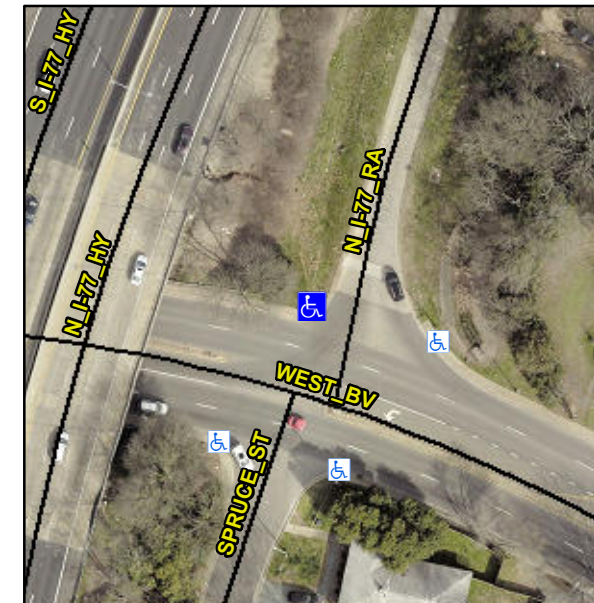
| | | Severity Score: 12.5 | |

**R304.5.1, R304.3.2**

| Compliance | Description | Data | Compliance | Description | Data |
|---|---|---|---|---|---|
| N/A | Ramp Width LT (in) | N/A | No | Ramp Width RT (in) | 40.0 |
| N/A | Ramp Slope LT (%) | N/A | No | Ramp Slope RT (%) | 10.7 |

**Remove & Replace Curb Ramp With Two New Directional Ramps or Equivalent.**
