Access Compliance Report Public Rights-of-Way (Curb Ramps)

Intersection ID: N/A Main Street: COPPER WY **Cross Street: N/A** Location: NW **Overall Compliance: No** ADA ID: A3AA02B8A306 Ramp Type: Perp Initial Pass/Fail: Fail **Severity Score:** 12.5

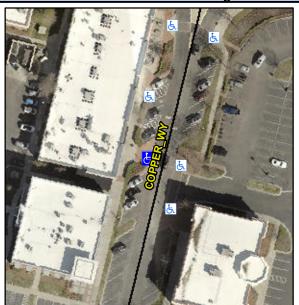
"	1 Cocibio Colditoli
į	Possible Solutions:
	Remove & Replace Entire Ramp.
100	
1	
100	Surveyor Notes:
	N/A
Š	PROW/ADA:
J	Not Found
7	
_
