## Access Compliance Report Public Rights-of-Way (Curb Ramps)

Intersection ID: 12431 Main Street: S\_CHURCH\_ST Cross Street: W\_MARTIN\_LUTHER\_KING\_JR\_BV Location: E

ADA ID: A43CC81C90A8 Ramp Type: PerpDiag Initial Pass/Fail: Fail Overall Compliance: No Severity Score: 13.75

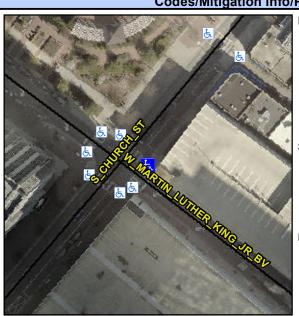
Surveyor Notes:
N/A

PROW/ADA:
Not Found, R304.2.2, R304.5.3

Remove & Replace Curb Ramp With
Two New Directional Ramps or
Equivalent.
