Access Compliance Report

Public Rights-of-Way

(Curb Ramps)

Intersection ID: 44449	Main Street: BAYVIEW_PY	Cross Street: PRESTBURY_BV	Location: E
ADA ID: A4E45B1DAE7B	Ramp Type: BlendTrans1	Initial Pass/Fail: Fail	Overall Compliance: No
		Severity Score: 8.75

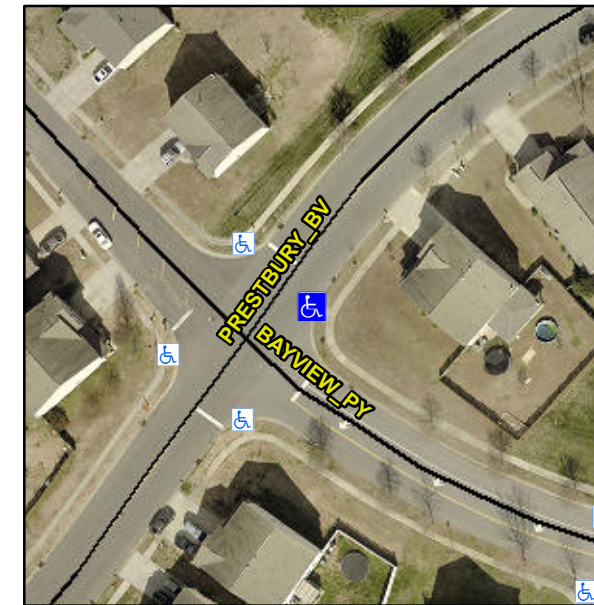
Not Found, R304.5.1

Compliance	Description	Data	Compliance	Description	Data
N/A	Ramp Length (in)	74.0	Yes	BlendTrans Slope (%)	2.5
No	Ramp Width (in)	36.0	Yes	BlendTrans XSlope (%)	0.4
N/A	Flare Type LT	N/A	N/A	Flare Type RT	N/A
N/A	Flare Slope LT (%)	N/A	N/A	Flare Slope RT (%)	N/A
N/A	Flare Traversable LT?	N/A	N/A	Flare Traversable RT?	N/A
N/A	Landing Length (in)	N/A	N/A	DWS Provided?	N/A
N/A	Landing Width (in)	N/A	N/A	DWS Contrast?	N/A
N/A	Landing Slope (%)	N/A	N/A	DWS Length (in)	N/A
N/A	Landing X Slope (%)	N/A	N/A	DWS Full Width?	N/A
N/A	Landing Curb? (Y/N)	N/A	N/A	DWS Offset (in)	N/A
N/A	Shared Landing?	N/A			
N/A	Gutter Ponding?	N/A	N/A	Gutter Slope (%)	N/A
N/A	Gutter Lip Ht (in)	N/A	N/A	Gutter X Slope (%)	N/A
N/A	Painted X Walk1?	No	N/A	Painted X Walk2?	No
	X Walk 1 Direction	To NW		X Walk 2 Direction	To SW
	X Walk 1 Width (in)	N/A		X Walk 2 Width (in)	N/A
	X Walk 1 Slope (%)	1.9		X Walk 2 Slope (%)	1.8
	X Walk 1 X Slope (%)	0.6		X Walk 2 X Slope (%)	1.0

N/A	Ramp inside XWalk1?	N/A	N/A	Ramp inside XWalk2?	N/A
	Road Slope (%)	0.8		Clear Space?	N/A
	Road X Slope (%)	0.2	N/A	Clear Space to XWalk (in)	N/A
N/A	Any Obstructions?	N/A	N/A	Storm Grate/Utility Hazard?	N/A
	Obstruction Type			Storm Grate/Utility Type	
		N/A			N/A
			Yes	Surface Condition? (G/P)	Good
			No	Curb Slope (%)	5.8

Remove & Replace Curb Ramp With Two New Directional Ramps or Equivalent.
