Access Compliance Report Public Rights-of-Way (Curb Ramps)

Intersection ID: 49932	Main Str	Main Street: WOBURN_RD				PAXTON_RUN_RD	Location:	NE		
ADA ID: A4F9AA5CBBFB	Ramp Ty	Ramp Type: Perp			s/Fa	il: Fail Overall (o Severity Score:	10		
Codes/Mitigation Info/Possible Solution				Field Measurements/Component Compliance						
Possible Solutions:									liance Description	Data
	4 6 6		Entiro Domo			Ramp Length (in)	46.0	Yes	Ramp Slope (%)	6.8
1 1 1 1 1 1 1 1 1 1 1 1 1 1 1 1 1 1 1 1		Remove & Replace	Entire Ramp.	N		Ramp Width (in)	46.0	No	Ramp XSlope (%)	4.8
				N/		Flare Type LT	40.0 N/A	N/A	Flare Type RT	4.0 N/A
	AL AN			N/		Flare Slope LT (%)	N/A		Flare Slope RT (%)	N/A
	AL OP					,			,	
		1		N/		Flare Traversable LT?	N/A		Flare Traversable RT?	N/A
				N/		Landing Length (in)	N/A		DWS Provided?	N/A
		Surveyor Notes:		N/		Landing Width (in)	N/A	N/A	DWS Contrast?	N/A
1 1 1 1 1 1 1 1 1 1 1 1 1 1 1 1 1 1 1		N/A		N/		Landing Slope (%)	N/A		DWS Length (in)	N/A
				N/	/A	Landing X Slope (%)	N/A	N/A	DWS Full Width?	N/A

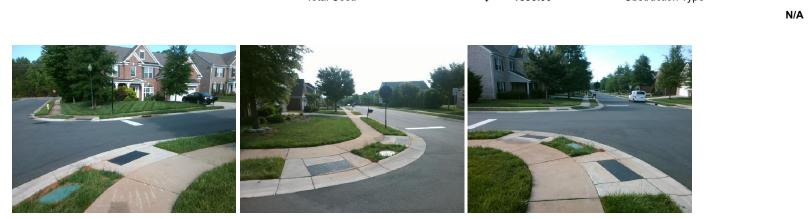
EUGULA IS				N/	/A	Landing Curb? (Y/N)	N/A	N/A	DWS Offset (in)	N/A
Moe dia				N/	/A	Shared Landing?	N/A			
		PROW/ADA:		N/	/ A	Gutter Ponding?	N/A	N/A	Gutter Slope (%)	N/A
A REAL PROPERTY AND A REAL	1 3	Not Found, R304.5	.1. R304.5.3	N/	Ά	Gutter Lip Ht (in)	N/A	N/A	Gutter X Slope (%)	N/A
a second a second	I TOTAL		,	N/	/A	Painted X Walk1?	No	N/A	Painted X Walk2?	N/A
						X Walk 1 Direction	To SW		X Walk 2 Direction	N/A
				N	/A	X Walk 1 Width (in)	N/A	N/A	X Walk 2 Width (in)	N/A
Street 1 Name	PAXTON RUN RD	•				X Walk 1 Slope (%)	1.2		X Walk 2 Slope (%)	N/A
Stop Condition-Street 2	StopSign					X Walk 1 X Slope (%)	2.2		X Walk 2 X Slope (%)	N/A
Street 2 Name	N/A			N	Δ/	Ramp inside XWalk1?	N/A	N/A	Ramp inside XWalk2?	N/A
Stop Condition-Street 1	N/A					Road Slope (%)	N/A	N/A	Clear Space?	N/A
	N/A					,	N/A	N/A	Clear Space to XWalk (in)	N/A
				N	/ A	Road X Slope (%)	N/A	N/A		N/A N/A
		Tatal Cast	* 4		A	Any Obstructions?	N/A	N/A	Storm Grate/Utility Hazard?	N/A

Total Cost:	\$ 1	850.00		Obstruction Type			Storm Grate/Utility Type	
							N/A			N/A
