Access Compliance Report

Public Rights-of-Way

(Curb Ramps)

| Intersection ID: 17138 | Main Street: IDLEWILD_RD | Cross Street: PINEY_GROVE_RD | Location: SW |

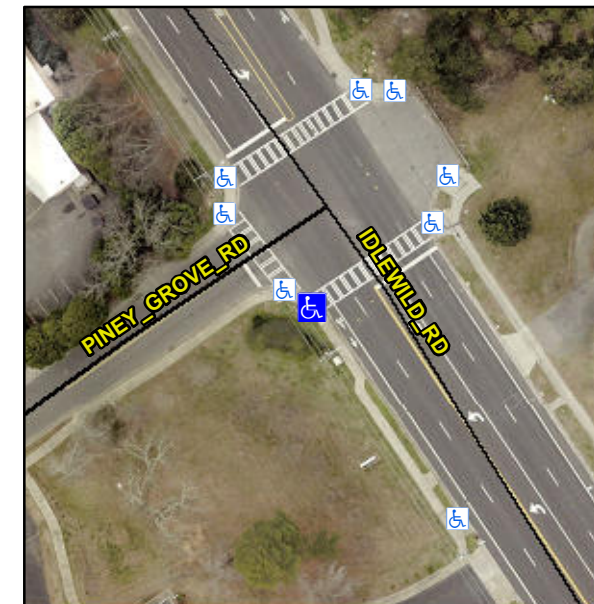
| ADA ID: A4FCF7912CC6 | Ramp Type: Para | Initial Pass/Fail: Fail | Overall Compliance: No |
| Severity Score: 13.75 | | | |

LT RP < 5%

R304.5.3, R304.3.2

| Compliance | Description | Data | Compliance | Description | Data |
|---|---|---|---|---|---|
| Yes | Ramp Slope LT (%) | 3.5 | No | Ramp Slope RT (%) | 8.5 |
| No | Ramp XSlope LT (%) | 2.6 | Yes | Ramp XSlope RT (%) | 0.1 |

Possible Solutions:

Remove & Replace Entire Ramp.
