Access Compliance Report Public Rights-of-Way (Curb Ramps)

Intersection ID: 5967Main Street:N_TRYON_STCross Street:MCCULLOUGH_DRLocation:NWADA ID: A53599D27973Ramp Type:PerpInitial Pass/Fail:FailOverall Compliance:NoSeverity Score:8.75

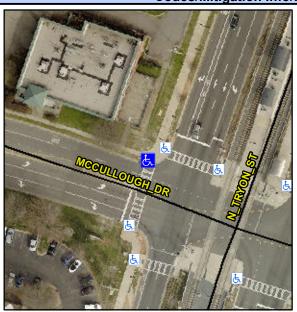
| Possible Solutions: | Cor |
|---|---|
| Not Found, R304.5.1 | N/A |

| Field Measurements/Component Compliance | | | | | | |
|---|---|---|---|---|---|---|
| No | Ramp Width (in) | 46.5 | Yes | Ramp | XSlope (%) | 0.4 |

| Possible Solutions: | Cor |
|---|---|
| Remove & Replace Entire Ramp. | N/A |
