Access Compliance Report

Public Rights-of-Way

(Curb Ramps)

Intersection ID: 7602	Main Street: WHITE_PLAINS_RD	Cross Street: YUMA_ST	Location: NW
ADA ID: A60CE72AAE62	Ramp Type: Combination1	Initial Pass/Fail: Fail	Overall Compliance: No
Severity Score: 46.25			
Codes/Mitigation Info/Possible Solution		Field Measurements/Component Compliance

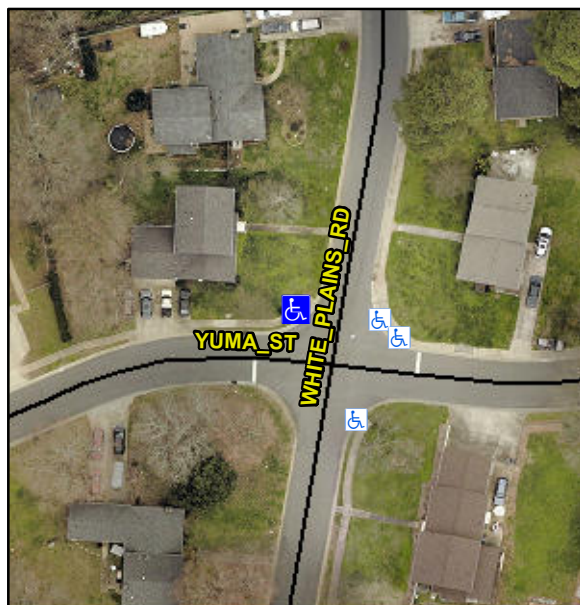
GTR GAP 1.0", RT RP < 5%

Not Found, R304.5.1, R304.5.3, R304.3.2

Compliance	Description	Data	Compliance	Description	Data
N/A	Ramp Length LT (in)	60.0	N/A	Ramp Length RT (in)	70.5
Yes	Ramp Width LT (in)	48.0	Yes	Ramp Width RT (in)	48.0
No	Ramp Slope LT (%)	14.4	Yes	Ramp Slope RT (%)	0.5
No	Ramp XSlope LT (%)	3.0	No	Ramp XSlope RT (%)	3.1
N/A	Ramp Length (in)	23.0	Yes	Ramp Slope (%)	7.7
No	Ramp Width (in)	43.0	No	Ramp XSlope (%)	6.8
N/A	Flare Type LT	N/A	N/A	Flare Type RT	N/A
N/A	Flare Slope LT (%)	N/A	N/A	Flare Slope RT (%)	N/A
N/A	Flare Traversable LT?	N/A	N/A	Flare Traversable RT?	N/A
N/A	Landing Length (in)	N/A	N/A	DWS Provided?	N/A
N/A	Landing Width (in)	N/A	N/A	DWS Contrast?	N/A
N/A	Landing Slope (%)	N/A	N/A	DWS Length (in)	N/A
N/A	Landing X Slope (%)	N/A	N/A	DWS Full Width?	N/A
N/A	Landing Curb? (Y/N)	N/A	N/A	DWS Offset (in)	N/A
N/A	Shared Landing?	N/A			
N/A	Gutter Ponding?	N/A	N/A	Gutter Slope (%)	N/A
N/A	Gutter Lip Ht (in)	N/A	N/A	Gutter X Slope (%)	N/A
N/A	Painted X Walk1?	No	N/A	Painted X Walk2?	N/A

Remove & Replace Entire Ramp.
