Access Compliance Report

Public Rights-of-Way

(Curb Ramps)

Intersection ID: 24197	Main Street: CHINA GROVE CHURCH RD	Cross Street: ERVIN LN	Location: NE
ADA ID: A637441E106F	Ramp Type: ParaDiag	Initial Pass/Fail: Fail	Overall Compliance: No
Severity Score: 12.5			
Codes/Mitigation Info/Possible Solution		Field Measurements/Component Compliance

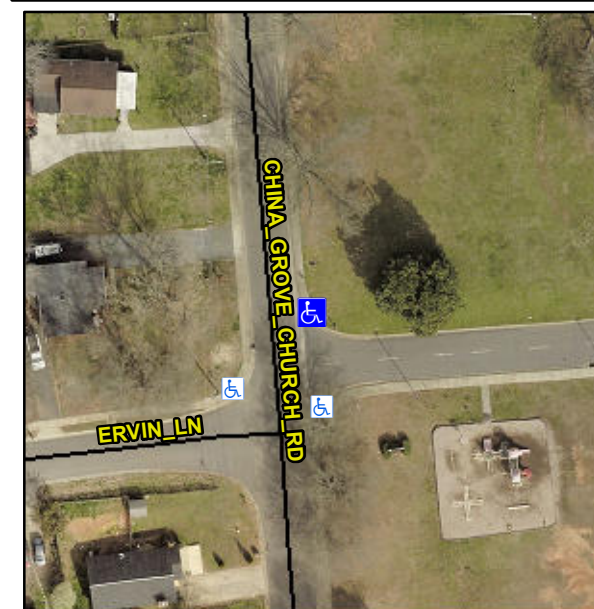
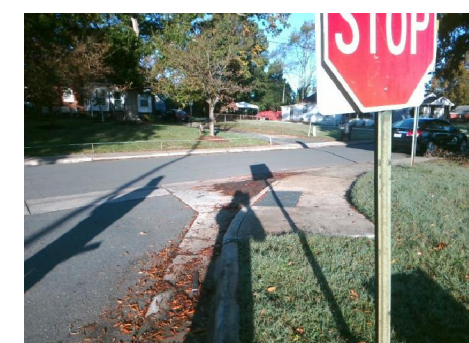
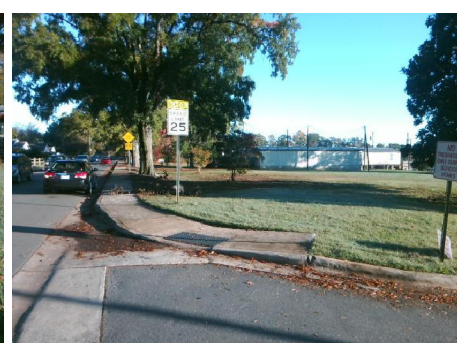
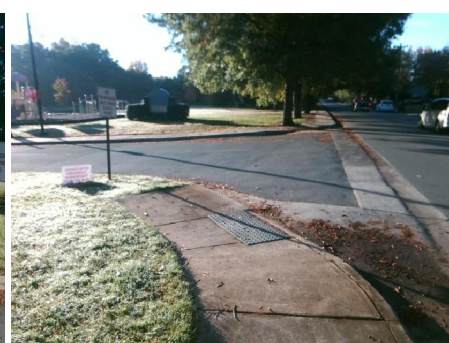
RT RP < 5%

PROW/ADA:

R304.3.2

Compliance	Description	Data	Compliance	Description	Data
N/A	Ramp Length LT (in)	51.0	N/A	Ramp Length RT (in)	60.0
Yes	Ramp Width LT (in)	59.0	Yes	Ramp Width RT (in)	60.0
No	Ramp Slope LT (%)	9.6	Yes	Ramp Slope RT (%)	2.3
Yes	Ramp XSlope LT (%)	1.8	Yes	Ramp XSlope RT (%)	1.7
N/A	Landing Length (in)	N/A	N/A	DWS Provided?	N/A
N/A	Landing Width (in)	N/A	N/A	DWS Contrast?	N/A
N/A	Landing Slope (%)	N/A	N/A	DWS Length (in)	N/A
N/A	Landing X Slope (%)	N/A	N/A	DWS Full Width?	N/A
N/A	Landing Curb? (Y/N)	N/A	N/A	DWS Offset (in)	N/A
N/A	Shared Landing?	N/A			
N/A	Gutter Ponding?	N/A	N/A	Gutter Slope (%)	N/A
N/A	Gutter Lip Ht (in)	N/A	N/A	Gutter X Slope (%)	N/A
N/A	Painted X Walk1?	No	N/A	Painted X Walk2?	No
	X Walk 1 Direction	To W		X Walk 2 Direction	To S
N/A	X Walk 1 Width (in)	N/A	N/A	X Walk 2 Width (in)	N/A
	X Walk 1 Slope (%)	0.8		X Walk 2 Slope (%)	3.6
	X Walk 1 X Slope (%)	1.1		X Walk 2 X Slope (%)	4.8
N/A	Ramp inside XWalk1?	N/A	N/A	Ramp inside XWalk2?	N/A

Road Slope (%)	0.0	N/A	Clear Space?	N/A
	Road X Slope (%)	4.6	N/A	Clear Space to XWalk (in)	N/A
N/A	Any Obstructions?	N/A	N/A	Storm Grate/Utility Hazard?	N/A
	Obstruction Type			Storm Grate/Utility Type	
		N/A			N/A
			Yes	Surface Condition? (G/P)	Good
			N/A	Curb Slope (%)	19.7

Possible Solutions:

Remove & Replace Curb Ramp With Two New Directional Ramps or Equivalent.

Total Cost:

\$ 3200.00
