Access Compliance Report

Public Rights-of-Way

(Curb Ramps)

Intersection ID: N/A	Main Street: GLEN_LAKE_DR	Cross Street: CASCADE_POINTE_BV	Location: N
ADA ID: A65B6D5462B2	Ramp Type: Perp	Initial Pass/Fail: Fail	Overall Compliance: No
		Severity Score: 25

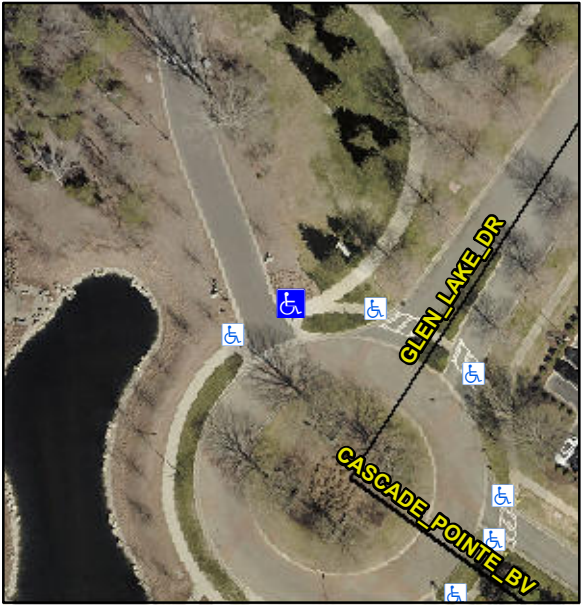
Possible Solutions:		Compliance	Description	Data
	Remove & Replace Entire Ramp.		No	Ramp Length (in)	74.0
			Yes	Ramp Width (in)	72.0
			N/A	Flare Type LT	N/A
			N/A	Flare Slope LT (%)	N/A
			N/A	Flare Traversable LT?	N/A
			N/A	Landing Length (in)	N/A
			N/A	Landing Width (in)	N/A
			N/A	Landing Slope (%)	N/A
			N/A	Landing X Slope (%)	N/A
<p>Surveyor Notes:</p> <p>N/A</p> <p>PROW/ADA:</p> <p>Not Found, R304.2.2, R304.5.3</p>			N/A	Flare Type RT	N/A
			N/A	Flare Slope RT (%)	N/A
			N/A	Flare Traversable RT?	N/A
			N/A	DWS Provided?	N/A
			N/A	DWS Contrast?	N/A
			N/A	DWS Length (in)	N/A
			N/A	DWS Full Width?	N/A
			N/A	DWS Offset (in)	N/A
			N/A	Gutter Ponding?	N/A
			N/A	Gutter Lip Ht (in)	N/A
			No	Painted X Walk1?	N/A
			To W	X Walk 1 Direction	N/A
			N/A	X Walk 1 Width (in)	N/A

1.2	X Walk 1 Slope (%)	N/A
			1.5	X Walk 1 X Slope (%)	N/A
			N/A	Ramp inside XWalk1?	N/A
			N/A	Road Slope (%)	N/A
			N/A	Road X Slope (%)	N/A
			N/A	Any Obstructions?	N/A
				Obstruction Type	N/A
Total Cost: \$ 1850.00			N/A	Storm Grate/Utility Hazard?	N/A
			N/A	Storm Grate/Utility Type	N/A
			Yes	Surface Condition? (G/P)	Good
