# Access Compliance Report

## Public Rights-of-Way

### (Curb Ramps)

| Intersection ID: N/A | Main Street: S_COLLEGE_ST | Cross Street: E_TRADE_ST | Location: SW |

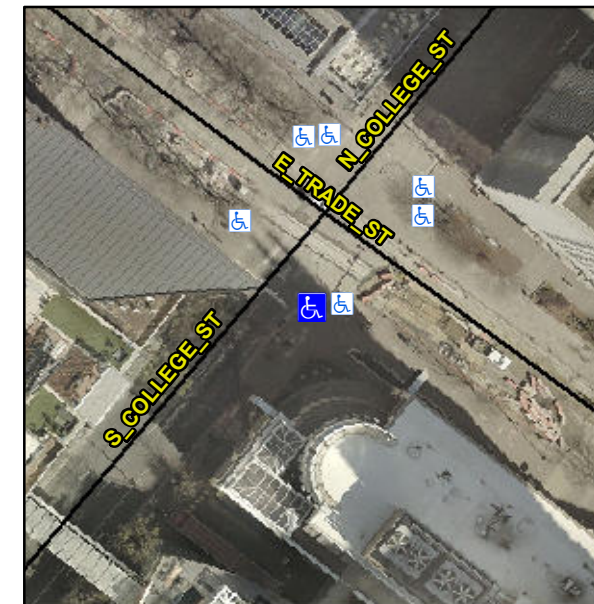
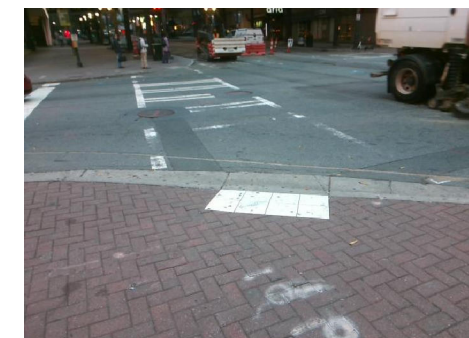
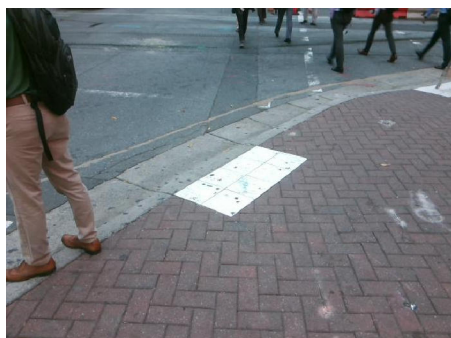
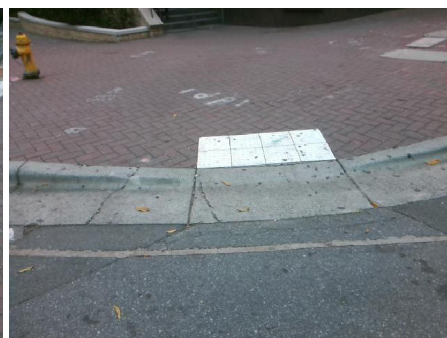
**Not Found, R304.5.3, R304.2.2-Perp, R304.3.2-Para, R304.2.3**

| Compliance | Description | Data | Compliance | Description | Data |
|---|---|---|---|---|---|
| Yes | Ramp Width (in) | 48.0 | No | Ramp XSlope (%) | 3.8 |
| N/A | Flare Slope LT (%) | 1.8 | No | Flare Slope RT (%) | 10.1 |
| No | Landing Slope (%) | 2.9 | Yes | DWS Length (in) | 24.0 |
| No | Landing X Slope (%) | 3.4 | Yes | DWS Full Width? | Yes |

**Remove & Replace Entire Ramp.**
