Access Compliance Report Public Rights-of-Way (Curb Ramps)

Intersection ID: N/AMain Street:LANGWELL_LNCross Street:INVERNESS_BAY_RDLocation:NWADA ID: A6B35A02739ERamp Type:PerpInitial Pass/Fail:FailOverall Compliance:NoSeverity Score:12.5

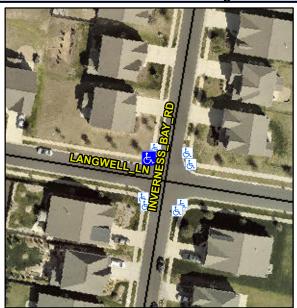
| Field Measurements/Component Compliance | | | | | | | |
|---|---|---|---|---|---|--|--|
| Yes | Ramp Width (in) | 48.0 | No | Ramp XSlope (%) | 6.6 | | |

| Possible Solutions: |
|---|
| Remove & Replace Entire Ramp. |
