# Access Compliance Report

## Public Rights-of-Way

### (Curb Ramps)

| Intersection ID: 3047 | Main Street: BUCK_CT | Cross Street: WHITE_STAG_DR | Location: NE |

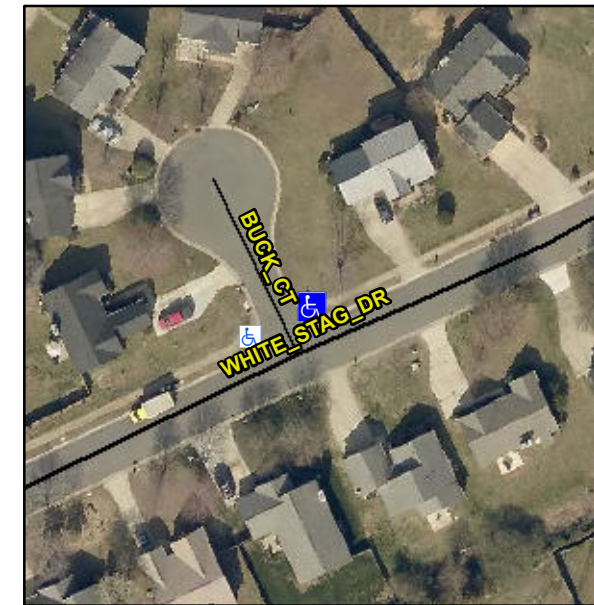
| ADA ID: A6D9E9FCB90F | Ramp Type: Perp | Initial Pass/Fail: Fail | Overall Compliance: No |

**Not Found, R304.5.1**

| Compliance | Description | Data | Compliance | Description | Data |
|---|---|---|---|---|---|
| No | Ramp Width (in) | 41.0 | Yes | Ramp XSlope (%) | 1.6 |

**Remove & Replace Entire Ramp.**
