## Access Compliance Report Public Rights-of-Way (Curb Ramps)

Intersection ID: N/AMain Street:PROVIDENCE\_RDCross Street:HEATHERWOOD\_APARTMENT\_RDLocation:SEADA ID: A6FC2B4A39C1Ramp Type:PerpDiagInitial Pass/Fail:FailOverall Compliance:NoSeverity Score:21.25

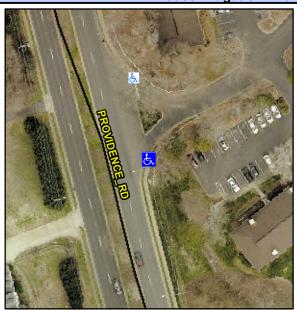
Not Found, R304.5.1, R304.2.2

Field Measure	ments/C	ompoi	nent Compliance	
Comp	Compliance Description		Compliance Description		Data
N/A	Ramp Length (in)	73.0	No	Ramp Slope (%)	11.3
No	Ramp Width (in)	47.0	Yes	Ramp XSlope (%)	1.4
N/A	Flare Type LT	N/A	N/A	Flare Type RT	N/A
N/A	Flare Slope LT (%)	N/A	N/A	Flare Slope RT (%)	N/A
N/A	Flare Traversable LT?	N/A	N/A	Flare Traversable RT?	N/A
N/A	Landing Length (in)	N/A	N/A	DWS Provided?	N/A
N/A	Landing Width (in)	N/A	N/A	DWS Contrast?	N/A
N/A	Landing Slope (%)	N/A	N/A	DWS Length (in)	N/A
N/A	Landing X Slope (%)	N/A	N/A	DWS Full Width?	N/A
N/A	Landing Curb? (Y/N)	N/A	N/A	DWS Offset (in)	N/A
N/A	Shared Landing?	N/A			
N/A	Gutter Ponding?	N/A	N/A	Gutter Slope (%)	N/A
N/A	Gutter Lip Ht (in)	N/A	N/A	Gutter X Slope (%)	N/A
N/A	Painted X Walk1?	No	N/A	Painted X Walk2?	No
	X Walk 1 Direction	To N		X Walk 2 Direction	To W
N/A	X Walk 1 Width (in)	N/A	N/A	X Walk 2 Width (in)	N/A
	X Walk 1 Slope (%)	5.4		X Walk 2 Slope (%)	3.4

X Walk 1 X Slope (%)	2.6		X Walk 2 X Slope (%)	4.8
N/A	Ramp inside XWalk1?	N/A	N/A	Ramp inside XWalk2?	N/A
	Road Slope (%)	2.7	N/A	Clear Space?	N/A
	Road X Slope (%)	6.0	N/A	Clear Space to XWalk (in)	N/A
N/A	Any Obstructions?	N/A	N/A	Storm Grate/Utility Hazard?	N/A
	Obstruction Type			Storm Grate/Utility Type	
		N/A			N/A
			Yes	Surface Condition? (G/P)	Good

ENTRANCE StopSign PROVIDENCE RD None Possible Solutions:

Remove & Replace Curb Ramp With Two New Directional Ramps or Equivalent.
