## **Access Compliance Report Public Rights-of-Way** (Curb Ramps)

Intersection ID: 8843 Main Street: DOUBLE OAKS RD **Cross Street: NEWLAND RD** Location: ADA ID: A726D8D0922B Ramp Type: Perp Initial Pass/Fail: Fail **Overall Compliance: No** Severity Score: 33.75

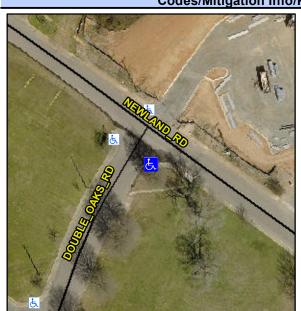
**DOUBLE OAKS RD** Street 1 Name Stop Condition-Street 2 StopSign Street 2 Name N/A Stop Condition-Street 1 N/A Possible Solutions: Remove & Replace Entire Ramp. Surveyor Notes: N/A PROW/ADA: Not Found, R304.5.1, R304.2.2

| Field Measurements/Component Compliance | | | | | | |
|---|---|---|---|---|---|---|
| | N/A | Ramp Length (in) | 46.0 | No | Ramp Slope (%) | 12.9 |
| | No | Ramp Width (in) | 37.0 | Yes | Ramp XSlope (%) | 1.8 |
