Access Compliance Report

Public Rights-of-Way

(Curb Ramps)

| Intersection ID: 21797 | Main Street: GALLERIA_BV | Cross Street: MONROE_RD | Location: SE |

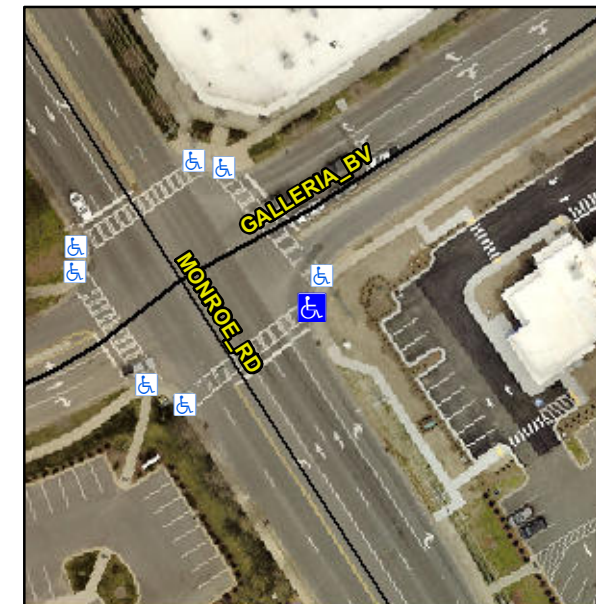
| ADA ID: A78BFDC4BDEB | Ramp Type: Perp | Initial Pass/Fail: Fail | Overall Compliance: No |
| Severity Score: 22.5 | | | |

R304.5.1, R304.2.2, R304.5.3

| Compliance | Description | Data | Compliance | Description | Data |
|---|---|---|---|---|---|
| N/A | Ramp Length (in) | 37.0 | No | Ramp Slope (%) | 10.9 |
| No | Ramp Width (in) | 44.0 | No | Ramp XSlope (%) | 3.3 |

Remove & Replace Entire Ramp.
