# Access Compliance Report

## Public Rights-of-Way

### (Curb Ramps)

Intersection ID: 14312	Main Street: W_TYVOLA_RD	Cross Street: SHADY_LN	Location: E
ADA ID: A78DCF5284FD	Ramp Type: Combination1	Initial Pass/Fail: Fail	Overall Compliance: No
		Severity Score: 22.5

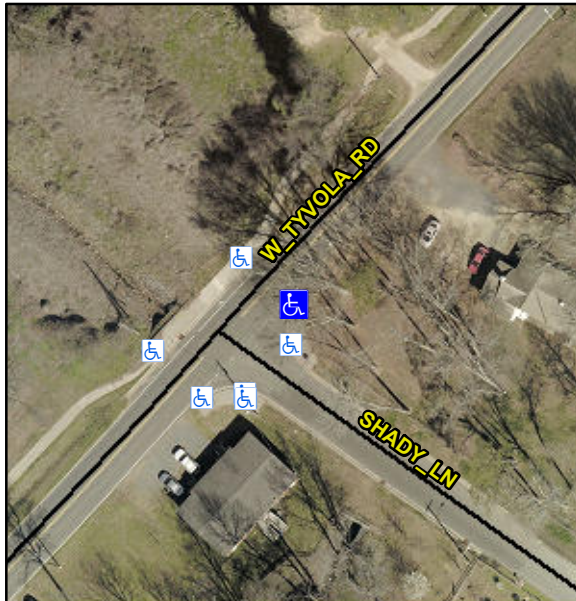
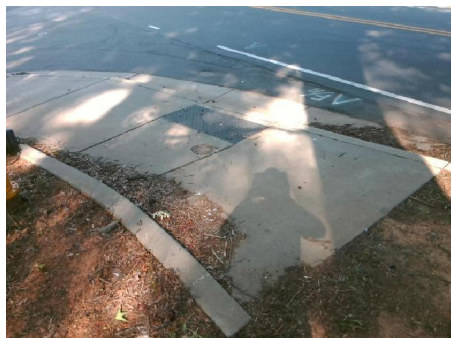
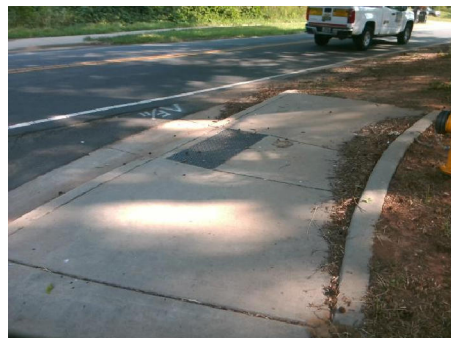
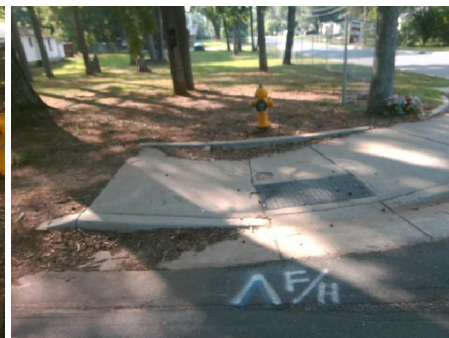
**RT RP < 5%**

**Not Found, R304.5.1, R304.3.2, R304.5.3**

Compliance	Description	Data	Compliance	Description	Data
N/A	Ramp Length LT (in)	68.0	N/A	Ramp Length RT (in)	58.0
Yes	Ramp Width LT (in)	83.0	Yes	Ramp Width RT (in)	83.0
No	Ramp Slope LT (%)	10.4	Yes	Ramp Slope RT (%)	3.0
Yes	Ramp XSlope LT (%)	0.6	No	Ramp XSlope RT (%)	2.1
N/A	Ramp Length (in)	83.0	Yes	Ramp Slope (%)	3.3
No	Ramp Width (in)	37.0	Yes	Ramp XSlope (%)	1.8
N/A	Flare Type LT	N/A	N/A	Flare Type RT	N/A
N/A	Flare Slope LT (%)	N/A	N/A	Flare Slope RT (%)	N/A
N/A	Flare Traversable LT?	N/A	N/A	Flare Traversable RT?	N/A
N/A	Landing Length (in)	N/A	N/A	DWS Provided?	N/A
N/A	Landing Width (in)	N/A	N/A	DWS Contrast?	N/A
N/A	Landing Slope (%)	N/A	N/A	DWS Length (in)	N/A
N/A	Landing X Slope (%)	N/A	N/A	DWS Full Width?	N/A
N/A	Landing Curb? (Y/N)	N/A	N/A	DWS Offset (in)	N/A
N/A	Shared Landing?	N/A			
N/A	Gutter Ponding?	N/A	N/A	Gutter Slope (%)	N/A
N/A	Gutter Lip Ht (in)	N/A	N/A	Gutter X Slope (%)	N/A
N/A	Painted X Walk1?	No	N/A	Painted X Walk2?	N/A

**Remove & Replace Entire Ramp.**
