Access Compliance Report Public Rights-of-Way (Curb Ramps)

Intersection ID: 11085 Main Street: GLENVILLE_AV Cross Street: PURSER_DR Location: SE

ADA ID: A7B1B383DBE0 Ramp Type: Combination1 Initial Pass/Fail: Fail Overall Compliance: No Severity Score: 37.5

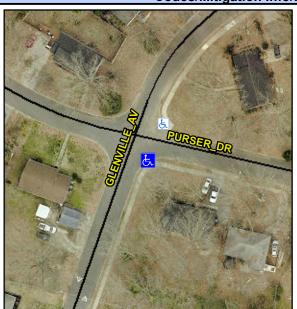
Not Found, R304.5.3, R304.3.2

Remove & Replace Entire Ramp.
