Access Compliance Report

Public Rights-of-Way

(Curb Ramps)

| Intersection ID: 13143 | Main Street: OSMOND_ST | Cross Street: BETHEL_RD | Location: NE |

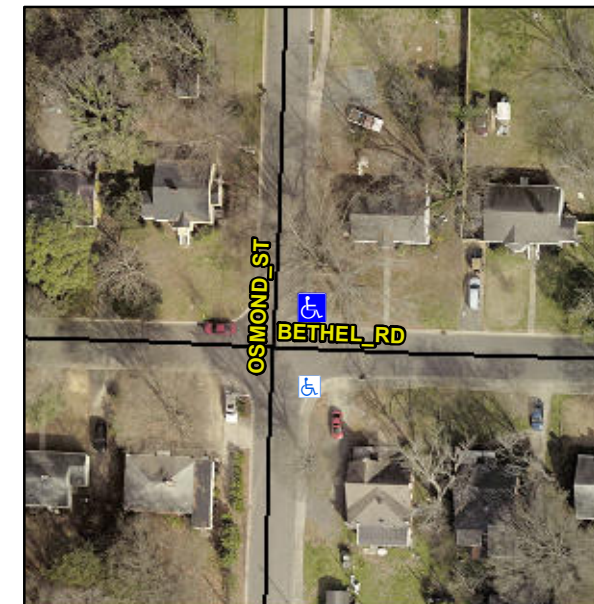
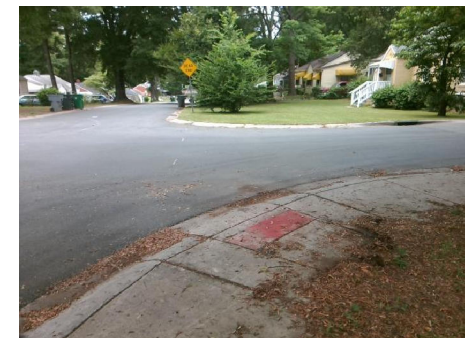
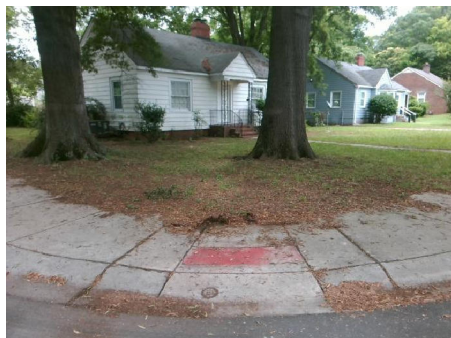
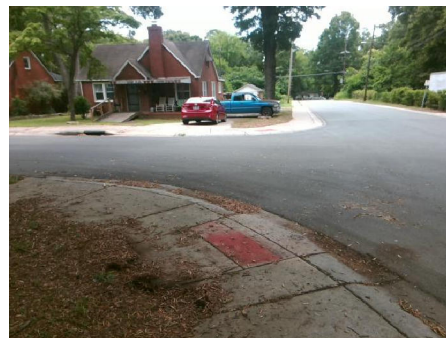
| ADA ID: A8D670EC58BA | Ramp Type: BlendTrans2 | Initial Pass/Fail: Fail | Overall Compliance: No |

Not Found, R304.5.1, R304.5.3

| Compliance | Description | Data | Compliance | Description | Data |
|---|---|---|---|---|---|
| No | Ramp Width (in) | 39.0 | No | BlendTrans XSlope (%) | 2.9 |
| N/A | Gutter Ponding? | Yes | N/A | Gutter Slope (%) | N/A |
| | | | No | Curb Slope (%) | 16.7 |

Remove & Replace Curb Ramp With Two New Directional Ramps or Equivalent.
