## Access Compliance Report Public Rights-of-Way (Curb Ramps)

Intersection ID: 25405Main Street:MARMOT\_POINT\_LNCross Street:PROVIDENCE\_PLANTATION\_LNLocation:NEADA ID: A93C05CCE6BERamp Type:PerpInitial Pass/Fail:FailOverall Compliance:NoSeverity Score:36.25

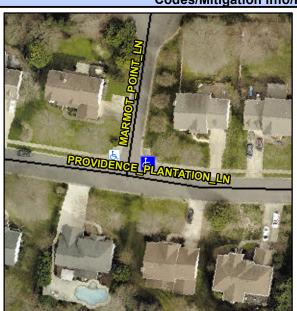
Comp	liance Description	Data	Comp	liance	Description	Data
N/A	Ramp Length (in)	96.0	Yes	Ramp	Slope (%)	7.8
No	Ramp Width (in)	29.0	No	Ramp	XSlope (%)	4.7
N/A	Flare Type LT	N/A	N/A	Flare	Type RT	N/A
N/A	Flare Slope LT (%)	N/A	N/A	Flare	Slope RT (%)	N/A
N/A	Flare Traversable LT?	N/A	N/A	Flare	Traversable RT?	N/A
N/A	Landing Length (in)	N/A	N/A	DWS	Provided?	N/A
N/A	Landing Width (in)	N/A	N/A	DWS	Contrast?	N/A
N/A	Landing Slope (%)	N/A	N/A	DWS	Length (in)	N/A
N/A	Landing X Slope (%)	N/A	N/A	DWS	Full Width?	N/A
N/A	Landing Curb? (Y/N)	N/A	N/A	DWS	Offset (in)	N/A
N/A	Shared Landing?	N/A				
N/A	Gutter Ponding?	N/A	N/A	Gutte	r Slope (%)	N/A
N/A	Gutter Lip Ht (in)	N/A	N/A	Gutte	r X Slope (%)	N/A
N/A	Painted X Walk1?	No	N/A	Paint	ed X Walk2?	N/A
	X Walk 1 Direction	To W		X Wa	lk 2 Direction	N/A
N/A	X Walk 1 Width (in)	N/A	N/A	X Wa	lk 2 Width (in)	N/A
	X Walk 1 Slope (%)	1.0		X Wa	lk 2 Slope (%)	N/A
	X Walk 1 X Slope (%)	3.3		X Wa	lk 2 X Slope (%)	N/A

N/A	Ramp inside XWalk1?	N/A	N/A	Ram	inside XWalk2?	N/A
	Road Slope (%)	N/A	N/A	Clear	Space?	N/A
	Road X Slope (%)	N/A	N/A	Clear	Space to XWalk (in)	N/A
N/A	Any Obstructions?	N/A	N/A	Storn	n Grate/Utility Hazard?	N/A
	Obstruction Type		l	Storn	n Grate/Utility Type	
		N/A				N/A
			Yes	Surfa	ce Condition? (G/P)	Good

Possible Solutions:
Remove & Replace Entire Ramp.
Surveyor Notes:
N/A
PROW/ADA:
Not Found, R304.5.1, R304.5.3
, , , , , , , , , , , , , , , , , , , ,
