Access Compliance Report Public Rights-of-Way (Curb Ramps)

Intersection ID: 3069Main Street: HEDGE_MAPLE_RDCross Street: HARTINGTON_PLLocation:SEADA ID: A93ECEA7EF8BRamp Type: BlendTrans1Initial Pass/Fail: FailOverall Compliance: NoSeverity Score:10

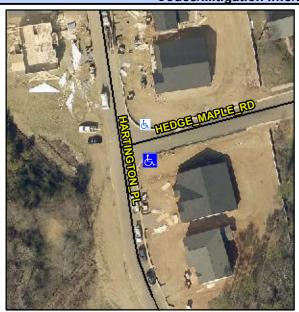
Not Found, R304.5.1, R304.5.3

(Compl	iance Description	Data	Compliance Description		Data
Ī	N/A	Ramp Length (in)	48.0	Yes	BlendTrans Slope (%)	2.6
ı	No	Ramp Width (in)	47.0	No	BlendTrans XSlope (%)	2.6
ı	N/A	Flare Type LT	N/A	N/A	Flare Type RT	N/A
ı	N/A	Flare Slope LT (%)	N/A	N/A	Flare Slope RT (%)	N/A
ı	N/A	Flare Traversable LT?	N/A	N/A	Flare Traversable RT?	N/A
ı	N/A	Landing Length (in)	N/A	N/A	DWS Provided?	N/A
ı	N/A	Landing Width (in)	N/A	N/A	DWS Contrast?	N/A
ı	N/A	Landing Slope (%)	N/A	N/A	DWS Length (in)	N/A
ı	N/A	Landing X Slope (%)	N/A	N/A	DWS Full Width?	N/A
ı	N/A	Landing Curb? (Y/N)	N/A	N/A	DWS Offset (in)	N/A
ı	N/A	Shared Landing?	N/A			
ı	N/A	Gutter Ponding?	N/A	N/A	Gutter Slope (%)	N/A
1	N/A	Gutter Lip Ht (in)	N/A	N/A	Gutter X Slope (%)	N/A
ı	N/A	Painted X Walk1?	No	N/A	Painted X Walk2?	No
		X Walk 1 Direction	To N		X Walk 2 Direction	To W
		X Walk 1 Width (in)	N/A		X Walk 2 Width (in)	N/A
		X Walk 1 Slope (%)	1.1		X Walk 2 Slope (%)	0.0

X Walk 1 X Slope (%)	5.5		X Walk 2 X Slope (%)	0.0
ı	N/A	Ramp inside XWalk1?	N/A	N/A	Ramp inside XWalk2?	N/A
		Road Slope (%)	4.3		Clear Space?	N/A
		Road X Slope (%)	2.6	N/A	Clear Space to XWalk (in)	N/A
ı	N/A	Any Obstructions?	N/A	N/A	Storm Grate/Utility Hazard?	N/A
		Obstruction Type			Storm Grate/Utility Type	
			N/A			N/A
				Yes	Surface Condition? (G/P)	Good
				No	Curb Slope (%)	10.0

Remove & Replace Curb Ramp With Two New Directional Ramps or Equivalent.
