Access Compliance Report

Public Rights-of-Way

(Curb Ramps)

| Intersection ID: 49126 | Main Street: CARLOTA_CT | Cross Street: LEGOLAS_LN | Location: NW |

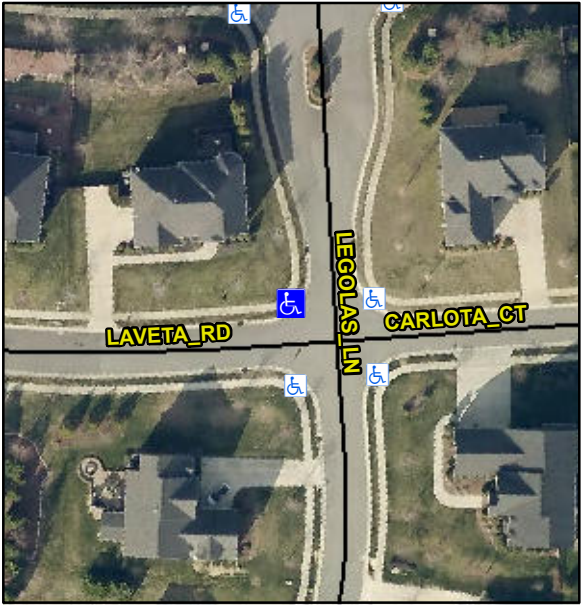
| ADA ID: A99DCC64462E | Ramp Type: PerpDiag | Initial Pass/Fail: Fail | Overall Compliance: No |
| | | Severity Score: 8.75 | |

| Codes/Mitigation Info/Possible Solution | | | Field Measurements/Component Compliance | | |
|---|---|---|---|---|---|
| | | | No | Ramp Width (in) | 41.0 |
| <p>Surveyor Notes:</p> <p>N/A</p> <p>PROW/ADA:</p> <p>Not Found, R304.5.1</p> | | | N/A | Flare Type RT | N/A |

| Codes/Mitigation Info/Possible Solution | | | Field Measurements/Component Compliance | | |
|---|---|---|---|---|---|
| | Remove & Replace Curb Ramp With Two New Directional Ramps or Equivalent. | | Yes | Ramp Length (in) | 47.0 |
