Access Compliance Report

Public Rights-of-Way

(Curb Ramps)

Intersection ID: 50941	Main Street: CANMORE_ST	Cross Street: CEDAR_WALK_LN	Location: NE
ADA ID: A9B7E14B6502	Ramp Type: PerpDiag	Initial Pass/Fail: Fail	Overall Compliance: No
Severity Score: 21.25			
Codes/Mitigation Info/Possible Solution		Field Measurements/Component Compliance

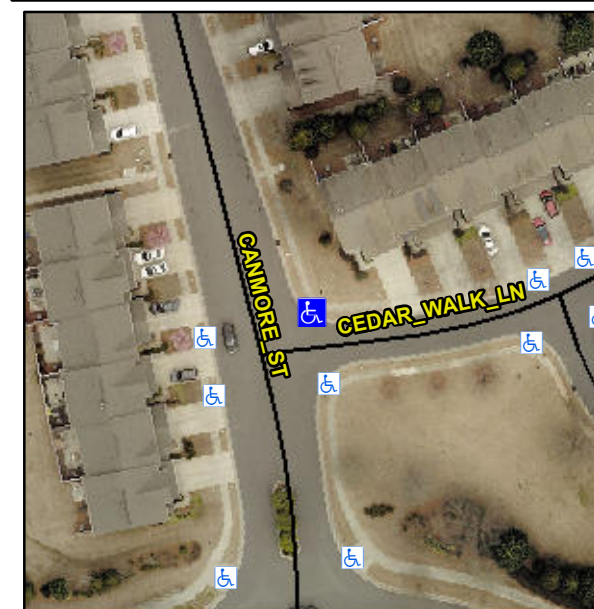
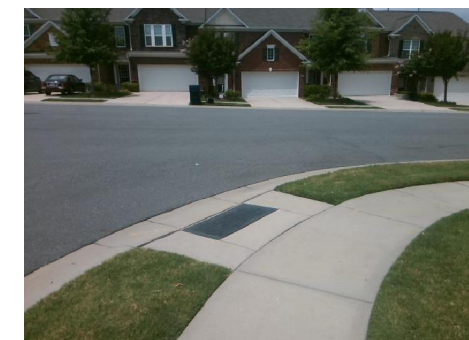
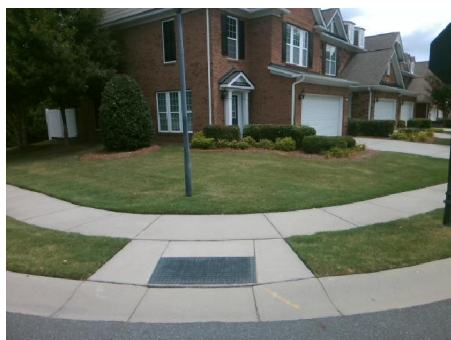
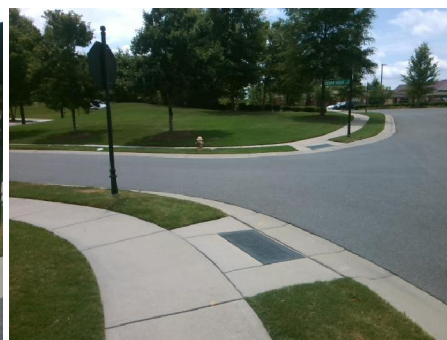
Not Found, R304.5.1, R304.2.2

Compliance	Description	Data	Compliance	Description	Data
N/A	Ramp Length (in)	46.0	No	Ramp Slope (%)	10.2
No	Ramp Width (in)	45.0	Yes	Ramp XSlope (%)	0.1
N/A	Flare Type LT	N/A	N/A	Flare Type RT	N/A
N/A	Flare Slope LT (%)	N/A	N/A	Flare Slope RT (%)	N/A
N/A	Flare Traversable LT?	N/A	N/A	Flare Traversable RT?	N/A
N/A	Landing Length (in)	N/A	N/A	DWS Provided?	N/A
N/A	Landing Width (in)	N/A	N/A	DWS Contrast?	N/A
N/A	Landing Slope (%)	N/A	N/A	DWS Length (in)	N/A
N/A	Landing X Slope (%)	N/A	N/A	DWS Full Width?	N/A
N/A	Landing Curb? (Y/N)	N/A	N/A	DWS Offset (in)	N/A
N/A	Shared Landing?	N/A			
N/A	Gutter Ponding?	N/A	N/A	Gutter Slope (%)	N/A
N/A	Gutter Lip Ht (in)	N/A	N/A	Gutter X Slope (%)	N/A
N/A	Painted X Walk1?	No	N/A	Painted X Walk2?	No
	X Walk 1 Direction	To W		X Walk 2 Direction	To S
N/A	X Walk 1 Width (in)	N/A	N/A	X Walk 2 Width (in)	N/A
	X Walk 1 Slope (%)	1.8		X Walk 2 Slope (%)	1.4
	X Walk 1 X Slope (%)	2.4		X Walk 2 X Slope (%)	2.3

Remove & Replace Curb Ramp With Two New Directional Ramps or Equivalent.
