## Access Compliance Report Public Rights-of-Way (Curb Ramps)

Intersection ID: 6102 Main Street: UNIVERSITY\_CITY\_BV Cross Street: UNIVERSITY\_PROFESSIONAL\_DR Location: SE

ADA ID: AA6B062DF31B Ramp Type: Combination1 Initial Pass/Fail: Fail Overall Compliance: No Severity Score: 47.5

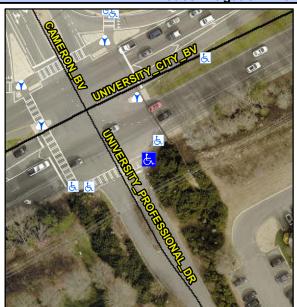
Not Found, R304.5.1, R304.5.1, R304.3.2

Remove & Replace Entire Ramp.
