# Access Compliance Report

## Public Rights-of-Way

### (Curb Ramps)

| Intersection ID: 7523 | Main Street: COTTONWOOD_ST | Cross Street: N_GRAHAM_ST | Location: SE |

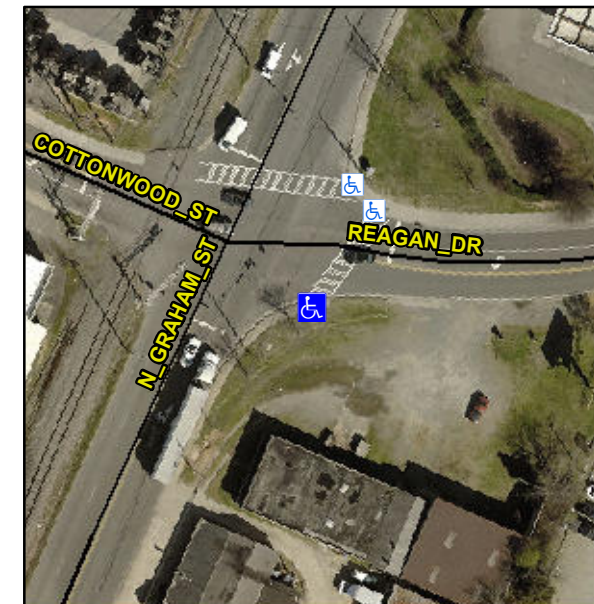
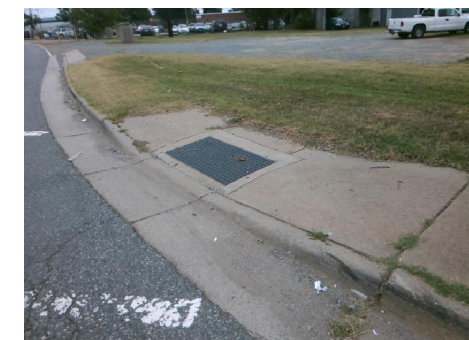
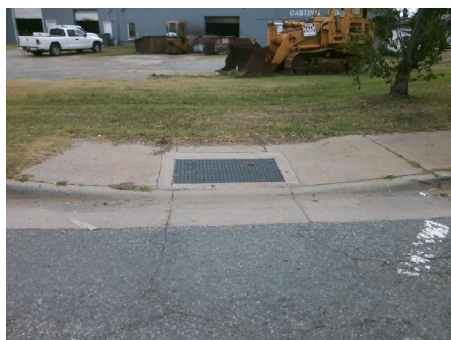
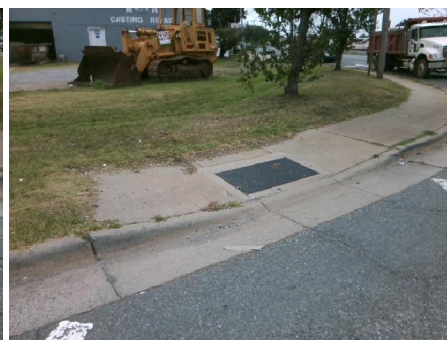
| ADA ID: AAA5685FAB5B | Ramp Type: Perp | Initial Pass/Fail: Fail | Overall Compliance: No |
| Severity Score: 8.75 | | | |

**Not Found, R304.5.1**

| Compliance | Description | Data | Compliance | Description | Data |
|---|---|---|---|---|---|
| No | Ramp Width (in) | 45.5 | Yes | Ramp XSlope (%) | 1.7 |

**Remove & Replace Entire Ramp.**

Total Cost: \$ 1850.00
