# Access Compliance Report

## Public Rights-of-Way

### (Curb Ramps)

| Intersection ID: 23917 | Main Street: BOSHAM_LN | Cross Street: WHITWORTH_WY | Location: NW |

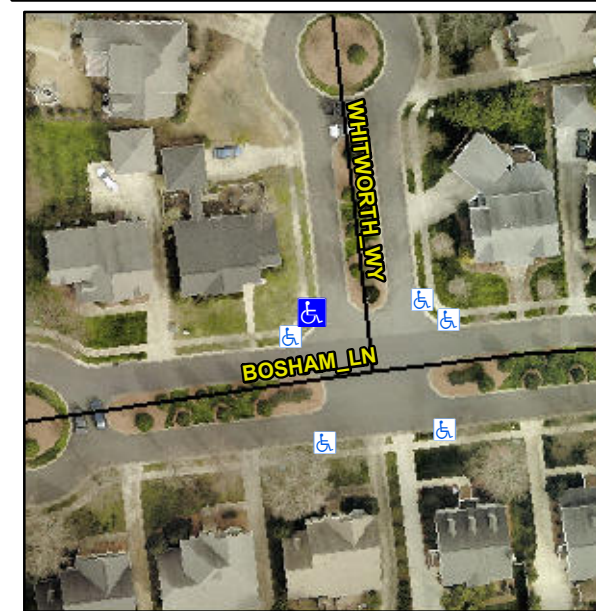
| ADA ID: AAC07818DE6B | Ramp Type: Perp | Initial Pass/Fail: Fail | Overall Compliance: No |

**Not Found, R304.5.1, R304.5.3**

| Compliance | Description | Data | Compliance | Description | Data |
|---|---|---|---|---|---|
| No | Ramp Width (in) | 37.0 | No | Ramp XSlope (%) | 2.6 |

**Remove & Replace Entire Ramp.**
