# Access Compliance Report

## Public Rights-of-Way (Curb Ramps)

| Intersection ID: 46144 | Main Street: EASTFIELD_VILLAGE_LN | Cross Street: ROCKY_FORD_CLUB_RD | Location: E |
| ADA ID: AACA399476DA | Ramp Type: BlendTrans1 | Initial Pass/Fail: Fail | Overall Compliance: No |

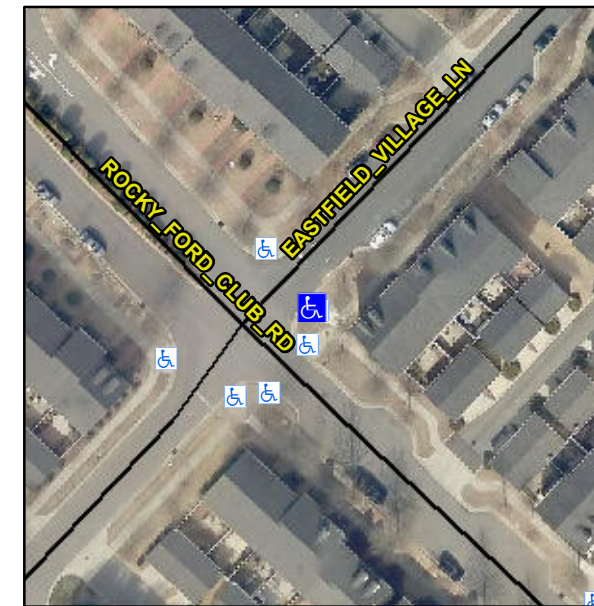
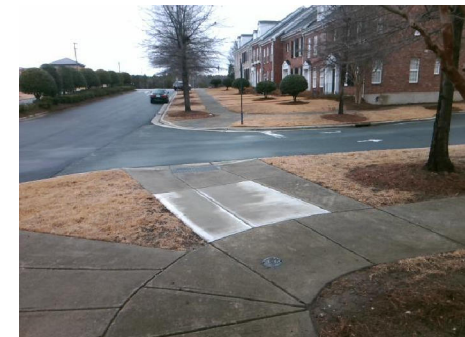
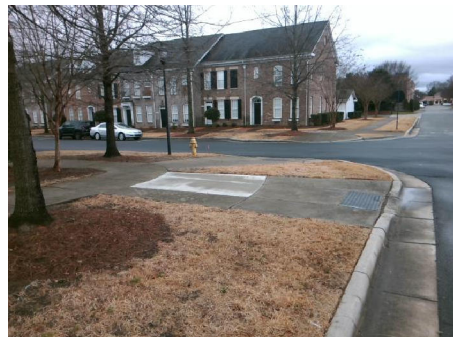
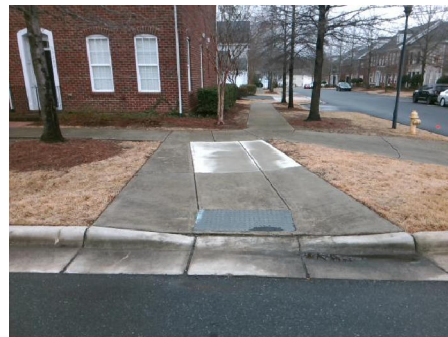
**Not Found, R304.5.3**

| Compliance | Description | Data | Compliance | Description | Data |
|---|---|---|---|---|---|
| Yes | Ramp Width (in) | 48.0 | No | BlendTrans XSlope (%) | 2.1 |
| | | | No | Curb Slope (%) | 12.5 |

**Remove & Replace Curb Ramp With Two New Directional Ramps or Equivalent.**
